Access Compliance Report

Public Rights-of-Way (Curb Ramps)

Intersection ID: 8193	Main Street: E_W_T_HARRIS_BV	Cross Street: GRIER_RD	Location: SW
ADA ID: EDE060F4C206	Ramp Type: Directional1	Initial Pass/Fail: Pass	Overall Compliance: No
Severity Score: 0			
Codes/Mitigation Info/Possible Solution		Field Measurements/Component Compliance

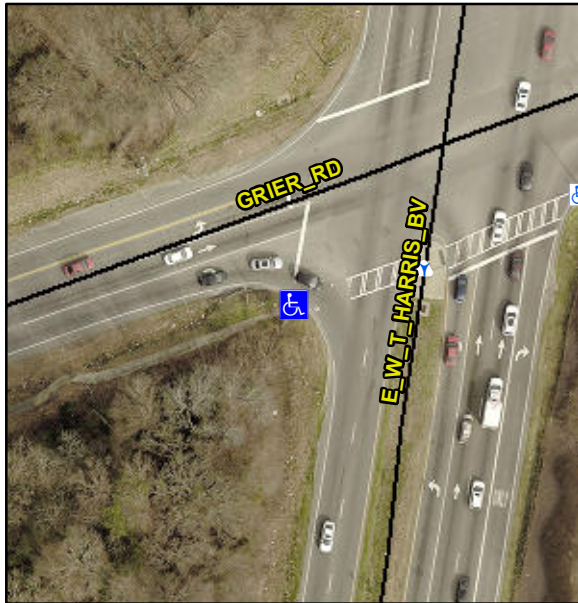
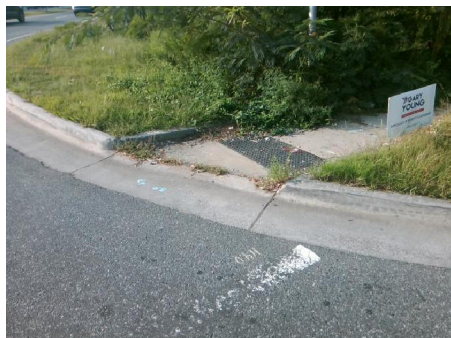
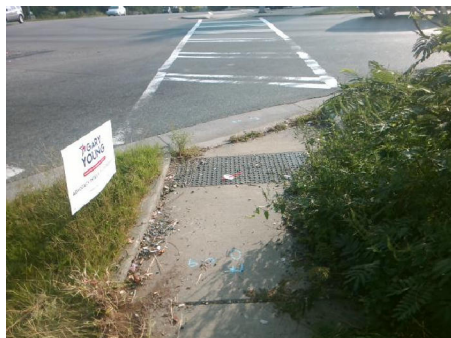
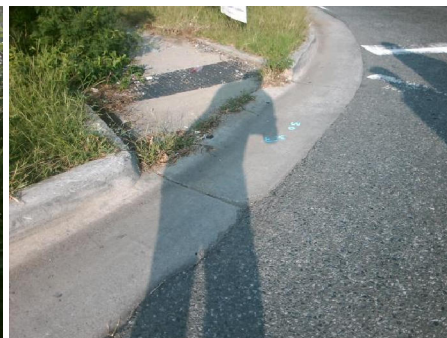
**Remove & Replace Landing. Gutter
Ponding Observed.**

Compliance	Description	Data	Compliance	Description	Data
N/A	Ramp Length (in)	77.0	Yes	Grade Break?	Yes
Yes	Ramp Width (in)	72.0	Yes	Grade Break Slope (%)	0.1
Yes	Ramp Slope (%)	0.7	Yes	Grade Break XSlope (%)	0.9
Yes	Ramp XSlope (%)	0.9			
Yes	Flare Type LT	N/A	Yes	Flare Type RT	N/A
N/A	Flare Slope LT (%)	N/A	N/A	Flare Slope RT (%)	N/A
N/A	Flare Traversable LT?	No	N/A	Flare Traversable RT?	No
Yes	Landing Length (in)	62.0	Yes	DWS Provided?	Yes
Yes	Landing Width (in)	72.0	Yes	DWS Contrast?	Yes
No	Landing Slope (%)	2.5	Yes	DWS Length (in)	25.0
Yes	Landing X Slope (%)	0.7	Yes	DWS Full Width?	Yes
N/A	Landing Curb? (Y/N)	No	Yes	DWS Offset LT (in)	40.0
N/A	Shared Landing?	No	Yes	DWS Offset RT (in)	0.0
No	Gutter Ponding?	Yes	Yes	Gutter Slope (%)	3.7
Yes	Gutter Lip Ht (in)	0.0	Yes	Gutter X Slope (%)	3.0
N/A	Painted X Walk1?	Yes		Road Slope (%)	4.7
	X Walk 1 Direction	To E		Road X Slope (%)	3.8
	X Walk 1 Width (in)	114.0		Clear Space?	Yes

X Walk 1 Slope (%)	4.7	N/A	Clear Space to XWalk (in)	N/A
	X Walk 1 X Slope (%)	3.8	Yes	Storm Grate/Utility Hazard?	No
Yes	Ramp inside XWalk1?	Yes		Storm Grate/Utility Type	
Yes	Any Obstructions?	No			N/A
	Obstruction Type		Yes	Surface Condition? (G/P)	Good
			N/A	Curb Slope (%)	N/A

Possible Solutions:
