Access Compliance Report

Public Rights-of-Way

(Curb Ramps)

Intersection ID: 28485	Main Street: REA_RD	Cross Street: WINDSOR_RIDGE_DR	Location: NW
ADA ID: EDE1544B878F	Ramp Type: BlendTrans2	Initial Pass/Fail: Fail	Overall Compliance: No
			Severity Score: 21.25

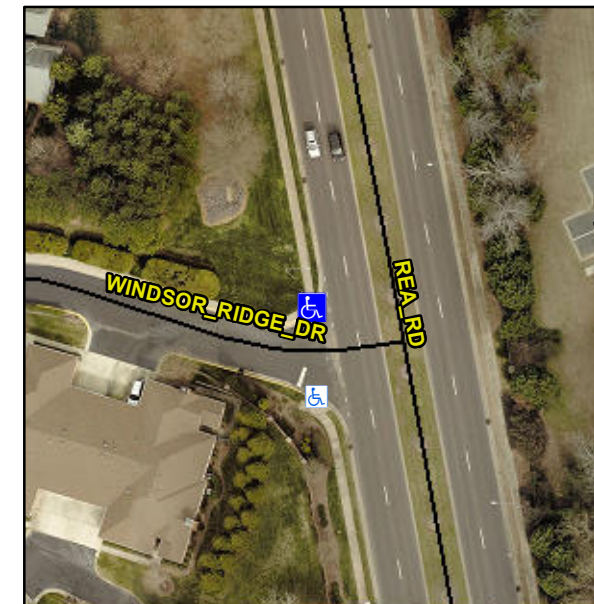
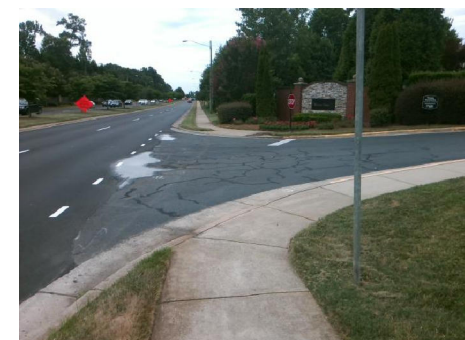
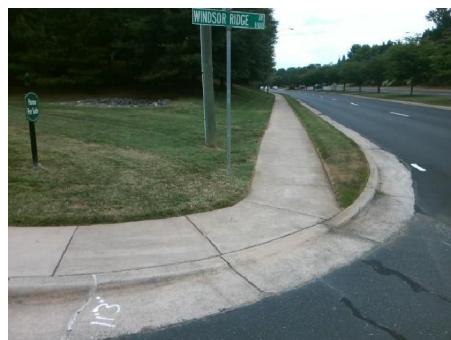
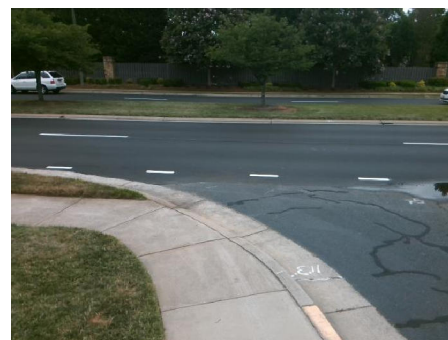
Not Found, R304.5.1, R304.5.3

Compliance	Description	Data	Compliance	Description	Data
N/A	Ramp Length (in)	47.0	Yes	BlendTrans Slope (%)	4.1
No	Ramp Width (in)	43.0	No	BlendTrans XSlope (%)	6.1
N/A	Flare Type LT	N/A	N/A	Flare Type RT	N/A
N/A	Flare Slope LT (%)	N/A	N/A	Flare Slope RT (%)	N/A
N/A	Flare Traversable LT?	N/A	N/A	Flare Traversable RT?	N/A
N/A	Landing Length (in)	N/A	N/A	DWS Provided?	N/A
N/A	Landing Width (in)	N/A	N/A	DWS Contrast?	N/A
N/A	Landing Slope (%)	N/A	N/A	DWS Length (in)	N/A
N/A	Landing X Slope (%)	N/A	N/A	DWS Full Width?	N/A
N/A	Landing Curb? (Y/N)	N/A	N/A	DWS Offset (in)	N/A
N/A	Shared Landing?	N/A			
N/A	Gutter Ponding?	N/A	N/A	Gutter Slope (%)	N/A
N/A	Gutter Lip Ht (in)	N/A	N/A	Gutter X Slope (%)	N/A
N/A	Painted X Walk1?	No	N/A	Painted X Walk2?	N/A
	X Walk 1 Direction	To S		X Walk 2 Direction	N/A
	X Walk 1 Width (in)	N/A		X Walk 2 Width (in)	N/A
	X Walk 1 Slope (%)	0.7		X Walk 2 Slope (%)	N/A
	X Walk 1 X Slope (%)	3.5		X Walk 2 X Slope (%)	N/A

N/A	Ramp inside XWalk1?	N/A	N/A	Ramp inside XWalk2?	N/A
	Road Slope (%)	3.5		Clear Space?	N/A
	Road X Slope (%)	0.7	N/A	Clear Space to XWalk (in)	N/A
N/A	Any Obstructions?	N/A	N/A	Storm Grate/Utility Hazard?	N/A
	Obstruction Type			Storm Grate/Utility Type	
		N/A			N/A
			Yes	Surface Condition? (G/P)	Good
			No	Curb Slope (%)	18.0

Remove & Replace Curb Ramp With Two New Directional Ramps or Equivalent.

Total Cost: \$ 3200.00
