Access Compliance Report

Public Rights-of-Way

(Curb Ramps)

Intersection ID: 10011236	Main Street: N_CHURCH_ST	Cross Street: WADSWORTH_PL	Location: SW
ADA ID: EDE16CCFD9E3	Ramp Type: Directional1	Initial Pass/Fail: Pass	Overall Compliance: No
Severity Score: 5			
Codes/Mitigation Info/Possible Solution		Field Measurements/Component Compliance

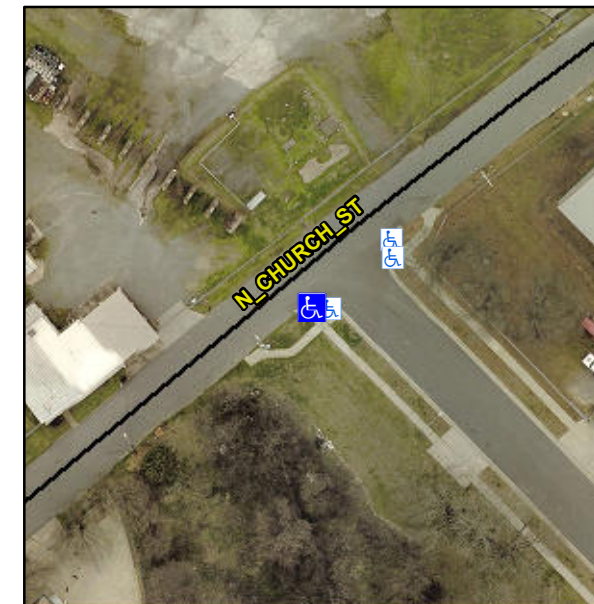
Compliance	Description	Data	Compliance	Description	Data
N/A	Ramp Length (in)	84.5	Yes	Grade Break?	Yes
Yes	Ramp Width (in)	53.5	Yes	Grade Break Slope (%)	0.3
Yes	Ramp Slope (%)	2.2	Yes	Grade Break XSlope (%)	1.6
Yes	Ramp XSlope (%)	0.6			
Yes	Flare Type LT	N/A	Yes	Flare Type RT	N/A
N/A	Flare Slope LT (%)	N/A	N/A	Flare Slope RT (%)	N/A
N/A	Flare Traversable LT?	No	N/A	Flare Traversable RT?	No
Yes	Landing Length (in)	69.5	Yes	DWS Provided?	Yes
Yes	Landing Width (in)	59.5	Yes	DWS Contrast?	Yes
Yes	Landing Slope (%)	1.6	Yes	DWS Length (in)	24.0
Yes	Landing X Slope (%)	1.8	Yes	DWS Full Width?	Yes
N/A	Landing Curb? (Y/N)	No	Yes	DWS Offset LT (in)	0.0
N/A	Shared Landing?	Yes	Yes	DWS Offset RT (in)	18.0
Yes	Gutter Ponding?	No	No	Gutter Slope (%)	8.5
Yes	Gutter Lip Ht (in)	0.0	No	Gutter X Slope (%)	3.3
N/A	Painted X Walk1?	No		Road Slope (%)	4.8
	X Walk 1 Direction	To NW		Road X Slope (%)	1.1
	X Walk 1 Width (in)	N/A		Clear Space?	Yes

X Walk 1 Slope (%)	4.8	N/A	Clear Space to XWalk (in)	N/A
	X Walk 1 X Slope (%)	1.1	Yes	Storm Grate/Utility Hazard?	No
N/A	Ramp inside XWalk1?	N/A		Storm Grate/Utility Type	
Yes	Any Obstructions?	No			N/A
	Obstruction Type		Yes	Surface Condition? (G/P)	Good
			N/A	Curb Slope (%)	6.2

Possible Solutions:

Remove & Replace Gutter.

R304.5.4, R304.5.3
