Access Compliance Report

Public Rights-of-Way

(Curb Ramps)

Intersection ID: 11144	Main Street: CLEMSON_AV	Cross Street: WOODSIDE_AV	Location: SW
ADA ID: EDE543FEC14B	Ramp Type: Perp	Initial Pass/Fail: Fail	Overall Compliance: No
		Severity Score: 1.25

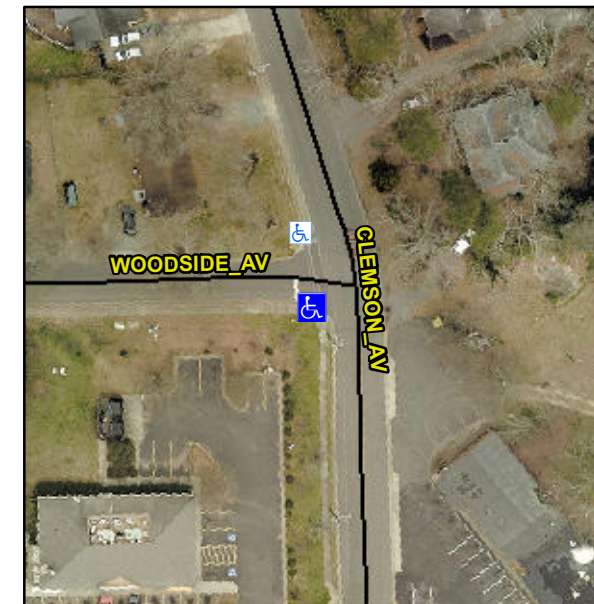
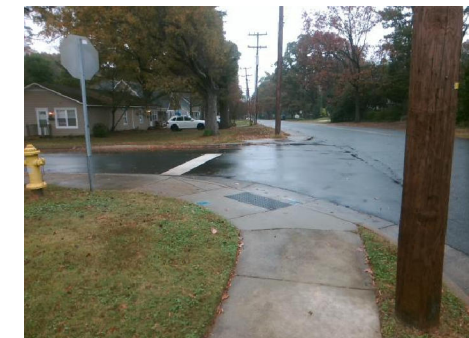
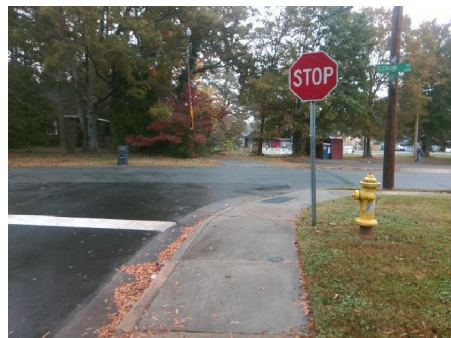
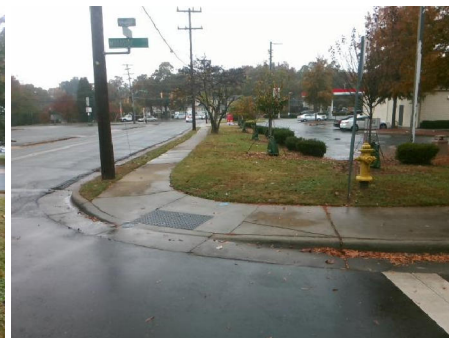
Not Found, R304.5.3

Compliance	Description	Data	Compliance	Description	Data
N/A	Ramp Length (in)	56.0	Yes	Ramp Slope (%)	5.5
Yes	Ramp Width (in)	63.0	No	Ramp XSlope (%)	2.5
N/A	Flare Type LT	N/A	N/A	Flare Type RT	N/A
N/A	Flare Slope LT (%)	N/A	N/A	Flare Slope RT (%)	N/A
N/A	Flare Traversable LT?	N/A	N/A	Flare Traversable RT?	N/A
N/A	Landing Length (in)	N/A	N/A	DWS Provided?	N/A
N/A	Landing Width (in)	N/A	N/A	DWS Contrast?	N/A
N/A	Landing Slope (%)	N/A	N/A	DWS Length (in)	N/A
N/A	Landing X Slope (%)	N/A	N/A	DWS Full Width?	N/A
N/A	Landing Curb? (Y/N)	N/A	N/A	DWS Offset (in)	N/A
N/A	Shared Landing?	N/A			
N/A	Gutter Ponding?	N/A	N/A	Gutter Slope (%)	N/A
N/A	Gutter Lip Ht (in)	N/A	N/A	Gutter X Slope (%)	N/A
N/A	Painted X Walk1?	No	N/A	Painted X Walk2?	N/A
	X Walk 1 Direction	To N		X Walk 2 Direction	N/A
N/A	X Walk 1 Width (in)	N/A	N/A	X Walk 2 Width (in)	N/A
	X Walk 1 Slope (%)	2.3		X Walk 2 Slope (%)	N/A
	X Walk 1 X Slope (%)	2.1		X Walk 2 X Slope (%)	N/A

Remove & Replace Entire Ramp.

Total Cost: \$ 1850.00
