# Access Compliance Report

## Public Rights-of-Way

### (Curb Ramps)

Intersection ID: 31193	Main Street: DICKSON_LN	Cross Street: OLDEN_CT	Location: SW
ADA ID: EDE677905E38	Ramp Type: Perp	Initial Pass/Fail: Fail	Overall Compliance: No
Severity Score: 8.75			
Codes/Mitigation Info/Possible Solution		Field Measurements/Component Compliance

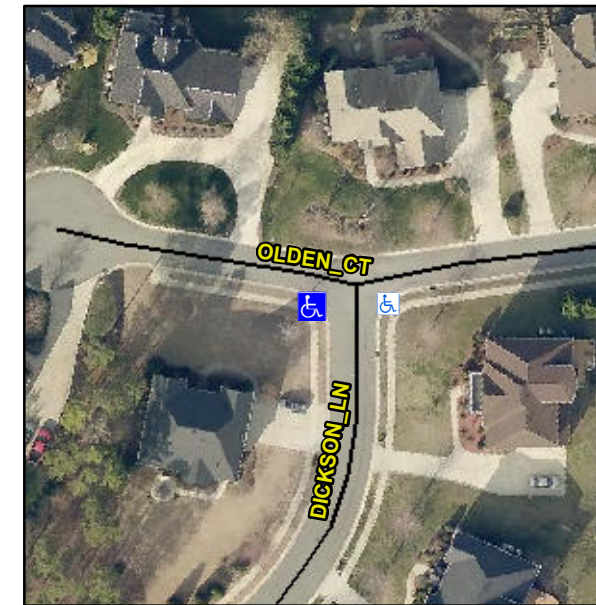
**Not Found, R304.5.1**

Compliance	Description	Data	Compliance	Description	Data
N/A	Ramp Length (in)	48.0	Yes	Ramp Slope (%)	8.1
No	Ramp Width (in)	43.0	Yes	Ramp XSlope (%)	0.5
N/A	Flare Type LT	N/A	N/A	Flare Type RT	N/A
N/A	Flare Slope LT (%)	N/A	N/A	Flare Slope RT (%)	N/A
N/A	Flare Traversable LT?	N/A	N/A	Flare Traversable RT?	N/A
N/A	Landing Length (in)	N/A	N/A	DWS Provided?	N/A
N/A	Landing Width (in)	N/A	N/A	DWS Contrast?	N/A
N/A	Landing Slope (%)	N/A	N/A	DWS Length (in)	N/A
N/A	Landing X Slope (%)	N/A	N/A	DWS Full Width?	N/A
N/A	Landing Curb? (Y/N)	N/A	N/A	DWS Offset (in)	N/A
N/A	Shared Landing?	N/A			
N/A	Gutter Ponding?	N/A	N/A	Gutter Slope (%)	N/A
N/A	Gutter Lip Ht (in)	N/A	N/A	Gutter X Slope (%)	N/A
N/A	Painted X Walk1?	No	N/A	Painted X Walk2?	N/A
	X Walk 1 Direction	To E		X Walk 2 Direction	N/A
N/A	X Walk 1 Width (in)	N/A	N/A	X Walk 2 Width (in)	N/A
	X Walk 1 Slope (%)	0.4		X Walk 2 Slope (%)	N/A
	X Walk 1 X Slope (%)	2.7		X Walk 2 X Slope (%)	N/A

N/A	Ramp inside XWalk1?	N/A	N/A	Ramp inside XWalk2?	N/A
	Road Slope (%)	N/A	N/A	Clear Space?	N/A
	Road X Slope (%)	N/A	N/A	Clear Space to XWalk (in)	N/A
N/A	Any Obstructions?	N/A	N/A	Storm Grate/Utility Hazard?	N/A
	Obstruction Type			Storm Grate/Utility Type	
		N/A			N/A
		Yes		Surface Condition? (G/P)	Good

Possible Solutions:

**Remove & Replace Entire Ramp.**

Total Cost: \$ 1850.00
