Access Compliance Report Public Rights-of-Way (Curb Ramps)

Intersection ID: 13752	Main Street: RENSSELAER_AV			Cross	Street:	SOUTH_BV	Location:	W			
ADA ID: EDE96E0A7F5C	7F5C Ramp Type: Perp			Initial	Pass/Fa	ail: Pass Overal	o Severity Score	: 26.5			
Codes/Mitigation Info/Possible Solution					Field Measurements/Component Compliance						
16 Strange	AND AND A	Possible Solutions:			Compliance Description			Data Compliance Description			
and the second of the		Remove & Replace Entir Remove & Replace Gutte	ire Ramr).	N/A	Ramp Length (in)	84.0	Yes	Ramp Slope (%)	6.1	
a state of the			•		No	Ramp Width (in)	43.0	No	Ramp XSlope (%)	3.4	
1 with a	1 1 10	•			N/A	Flare Type LT	Sloped	N/A	Flare Type RT	Sloped	
the states					N/A	Flare Slope LT (%)	11.7	N/A	Flare Slope RT (%)	0.3	
141					N/A	Flare Traversable LT?	No	N/A	Flare Traversable RT?	No

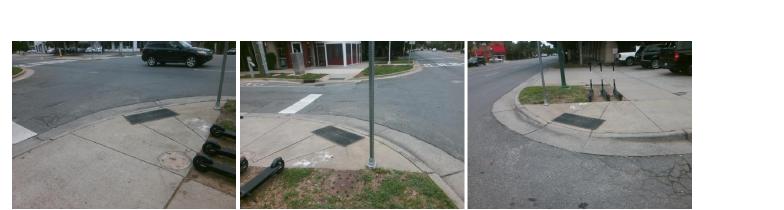
e.	Surveyor Notes:			No	Landing Length (in)	N/A	Yes	DWS Provided?	Yes	
6					No	Landing Width (in)	N/A	Yes	DWS Contrast?	Yes	
		N/A			No	Landing Slope (%)	N/A	Yes	DWS Length (in)	24.0	
					No	Landing X Slope (%)	N/A	Yes	DWS Full Width?	Yes

*	CORD C	44			N/A	Landing Curb? (Y/N)	No	No	DWS Offset (in)	6.0	
	5. THE				N/A	Shared Landing?	No				
and the to		PROW/ADA:			Yes	Gutter Ponding?	No	Yes	Gutter Slope (%)	0.8	
7 3 1 A	12 . 60	Not Found, R304.5.1, R	304 5 3		No	Gutter Lip Ht (in)	1.0	No	Gutter X Slope (%)	5.3	
the IR I A	6	R304.2.1, R304.2.2-Perp		.2-	N/A	Painted X Walk1?	No	N/A	Painted X Walk2?	N/A	
Star X and Y	Para, R305.2, R302.7.2			X Walk 1 Direction	To NE		X Walk 2 Direction	N/A			
				N/A	X Walk 1 Width (in)	N/A	N/A	X Walk 2 Width (in)	N/A		
Street 1 Name	RESSELAER AV					X Walk 1 Slope (%)	0.1		X Walk 2 Slope (%)	N/A	
Stop Condition-Street 2	StopSign					X Walk 1 X Slope (%)	4.8		X Walk 2 X Slope (%)	N/A	
Street 2 Name	N/A				N/A	Ramp inside XWalk1?	N/A	N/A	Ramp inside XWalk2?	N/A	
Stop Condition-Street 1	N/A					Road Slope (%)	N/A	N/A	Clear Space?	Yes	
						Road X Slope (%)	N/A	N/A	Clear Space to XWalk (in)	N/A	
					Yes	Any Obstructions?	No	Yes	Storm Grate/Utility Hazard?	No

Yes Surface Condition? (G/P)

Good

Total Cost:	\$	2600.00		Obstruction Type			Storm Grate/Utility Type		
							N/A			N/A	
								•
