## Access Compliance Report Public Rights-of-Way (Curb Ramps)

Intersection ID: 17169Main Street:IDLEWILD\_RDCross Street:CEDARS\_EAST\_CTLocation:NEADA ID: EDEAD630C967Ramp Type:PerpInitial Pass/Fail:FailOverall Compliance:NoSeverity Score:33.75

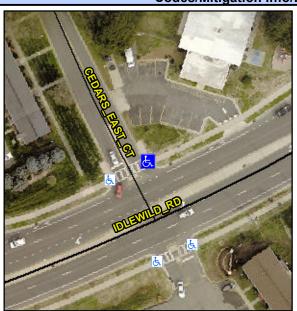
Field Measurements/Component Compliance							
Compliance Description D		Data	Comp	liance Description	Data		
N/A	Ramp Length (in)	85.0	No	Ramp Slope (%)	8.9		
No	Ramp Width (in)	45.0	No	Ramp XSlope (%)	6.9		
N/A	Flare Type LT	N/A	N/A	Flare Type RT	N/A		
N/A	Flare Slope LT (%)	N/A	N/A	Flare Slope RT (%)	N/A		
N/A	Flare Traversable LT?	N/A	N/A	Flare Traversable RT?	N/A		
N/A	Landing Length (in)	N/A	N/A	DWS Provided?	N/A		
N/A	Landing Width (in)	N/A	N/A	DWS Contrast?	N/A		
N/A	Landing Slope (%)	N/A	N/A	DWS Length (in)	N/A		
N/A	Landing X Slope (%)	N/A	N/A	DWS Full Width?	N/A		
N/A	Landing Curb? (Y/N)	N/A	N/A	DWS Offset (in)	N/A		
N/A	Shared Landing?	N/A					
N/A	Gutter Ponding?	N/A	N/A	Gutter Slope (%)	N/A		
N/A	Gutter Lip Ht (in)	N/A	N/A	Gutter X Slope (%)	N/A		
N/A	Painted X Walk1?	Yes	N/A	Painted X Walk2?	N/A		
	X Walk 1 Direction	To SW		X Walk 2 Direction	N/A		
N/A	X Walk 1 Width (in)	110.0	N/A	X Walk 2 Width (in)	N/A

X Walk 1 Slope (%)	1.3		X Walk 2 Slope (%)	N/A		
	X Walk 1 X Slope (%)	4.5		X Walk 2 X Slope (%)	N/A		
N/A	Ramp inside XWalk1?	Yes	N/A	Ramp inside XWalk2?	N/A		
	Road Slope (%)	N/A	N/A	Clear Space?	N/A		
	Road X Slope (%)	N/A	N/A	Clear Space to XWalk (in)	N/A		
N/A	Any Obstructions?	N/A	N/A	Storm Grate/Utility Hazard?	N/A		
	Obstruction Type			Storm Grate/Utility Type			
		N/A			N/A		
			Yes	Surface Condition? (G/P)	Good

<u> </u>	1 033ibic Colation	
	Possible Solutions:	9
	Remove & Replace Entire Ramp.	ľ
1		ı
No.		1
(0)		
p	Surveyor Notes:	,
		,
	N/A	
-		
Z		ı
1	PROW/ADA:	ı
	Not Found, R304.5.1, R304.2.2,	1
4	R304.5.3	ı
23		
X		ı
		ı

Total Cost:	\$ 1850.0
