# Access Compliance Report

## Public Rights-of-Way

### (Curb Ramps)

Intersection ID: 30613	Main Street: GOLF_LINKS_DR	Cross Street: PROVIDENCE_RD	Location: SW
ADA ID: EDEC2578FBAA	Ramp Type: Perp	Initial Pass/Fail: Fail	Overall Compliance: No
Severity Score: 13.75			
Codes/Mitigation Info/Possible Solution		Field Measurements/Component Compliance

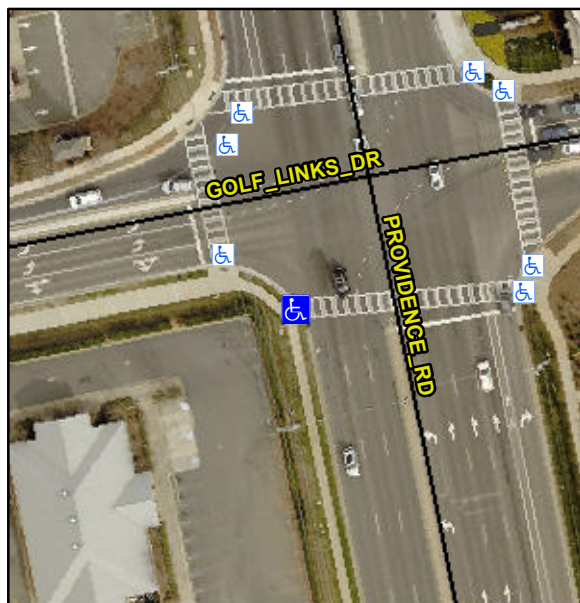
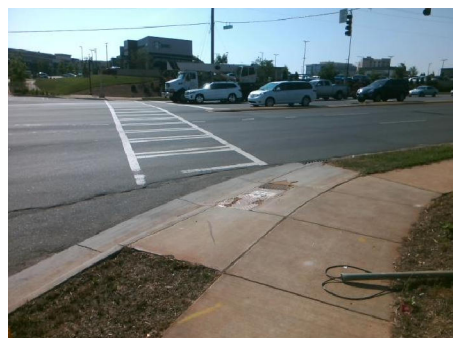
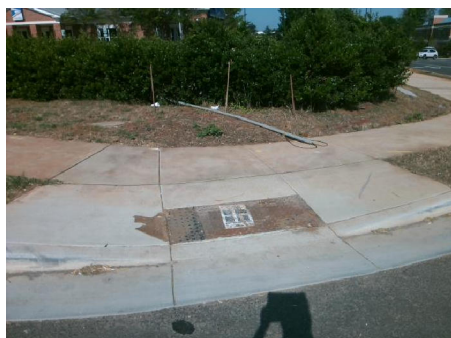
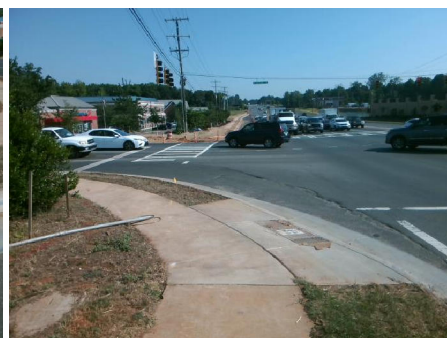
**Not Found, R304.2.2, R304.5.3**

Compliance	Description	Data	Compliance	Description	Data
N/A	Ramp Length (in)	47.0	No	Ramp Slope (%)	9.6
Yes	Ramp Width (in)	59.0	No	Ramp XSlope (%)	4.1
N/A	Flare Type LT	N/A	N/A	Flare Type RT	N/A
N/A	Flare Slope LT (%)	N/A	N/A	Flare Slope RT (%)	N/A
N/A	Flare Traversable LT?	N/A	N/A	Flare Traversable RT?	N/A
N/A	Landing Length (in)	N/A	N/A	DWS Provided?	N/A
N/A	Landing Width (in)	N/A	N/A	DWS Contrast?	N/A
N/A	Landing Slope (%)	N/A	N/A	DWS Length (in)	N/A
N/A	Landing X Slope (%)	N/A	N/A	DWS Full Width?	N/A
N/A	Landing Curb? (Y/N)	N/A	N/A	DWS Offset (in)	N/A
N/A	Shared Landing?	N/A			
N/A	Gutter Ponding?	Yes	N/A	Gutter Slope (%)	N/A
N/A	Gutter Lip Ht (in)	2.0	N/A	Gutter X Slope (%)	N/A
N/A	Painted X Walk1?	Yes	N/A	Painted X Walk2?	N/A
	X Walk 1 Direction	To E		X Walk 2 Direction	N/A
N/A	X Walk 1 Width (in)	104.0	N/A	X Walk 2 Width (in)	N/A
	X Walk 1 Slope (%)	3.4		X Walk 2 Slope (%)	N/A
	X Walk 1 X Slope (%)	3.8		X Walk 2 X Slope (%)	N/A

N/A	Ramp inside XWalk1?	Yes	N/A	Ramp inside XWalk2?	N/A
	Road Slope (%)	N/A	N/A	Clear Space?	N/A
	Road X Slope (%)	N/A	N/A	Clear Space to XWalk (in)	N/A
N/A	Any Obstructions?	N/A	N/A	Storm Grate/Utility Hazard?	N/A
	Obstruction Type			Storm Grate/Utility Type	
		N/A			N/A
		Yes		Surface Condition? (G/P)	Good

**Remove & Replace Entire Ramp.**
