Access Compliance Report

Public Rights-of-Way

(Curb Ramps)

Intersection ID: 15373	Main Street: WINFIELD_DR	Cross Street: PIERSON_DR	Location: SW
ADA ID: EDF5BE3734E7	Ramp Type: Perp	Initial Pass/Fail: Fail	Overall Compliance: No
Severity Score: 13.75			
Codes/Mitigation Info/Possible Solution		Field Measurements/Component Compliance

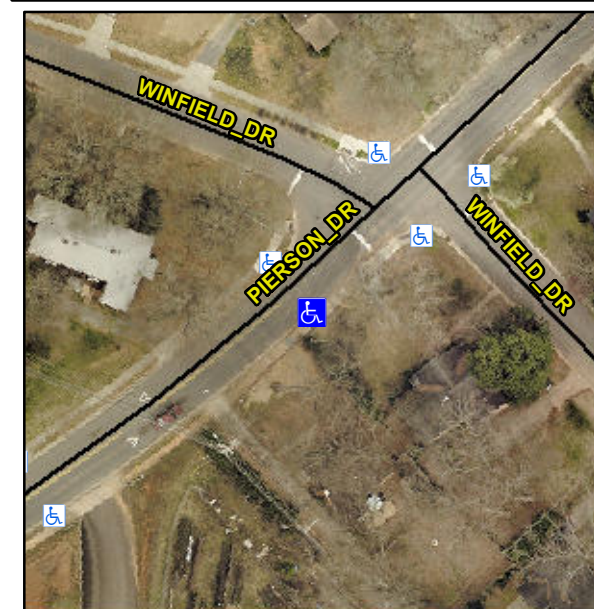
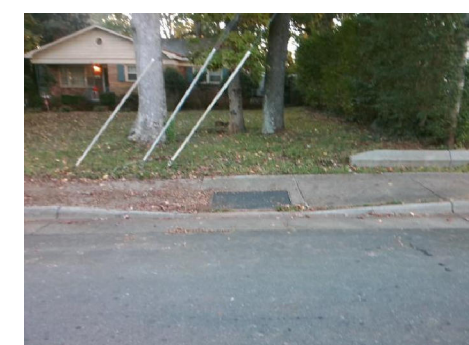
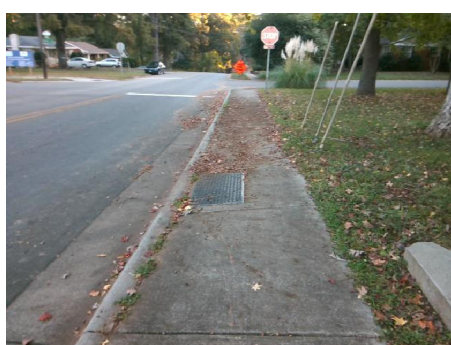
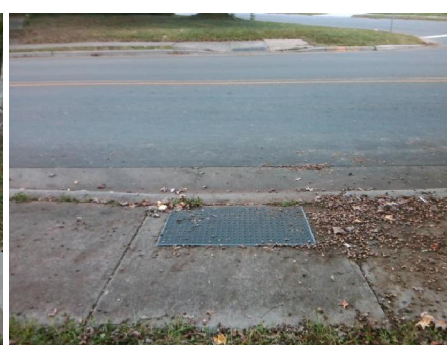
Not Found, R304.2.2, R304.5.3

Compliance	Description	Data	Compliance	Description	Data
N/A	Ramp Length (in)	61.0	No	Ramp Slope (%)	10.1
Yes	Ramp Width (in)	62.5	No	Ramp XSlope (%)	3.9
N/A	Flare Type LT	N/A	N/A	Flare Type RT	N/A
N/A	Flare Slope LT (%)	N/A	N/A	Flare Slope RT (%)	N/A
N/A	Flare Traversable LT?	N/A	N/A	Flare Traversable RT?	N/A
N/A	Landing Length (in)	N/A	N/A	DWS Provided?	N/A
N/A	Landing Width (in)	N/A	N/A	DWS Contrast?	N/A
N/A	Landing Slope (%)	N/A	N/A	DWS Length (in)	N/A
N/A	Landing X Slope (%)	N/A	N/A	DWS Full Width?	N/A
N/A	Landing Curb? (Y/N)	N/A	N/A	DWS Offset (in)	N/A
N/A	Shared Landing?	N/A			
N/A	Gutter Ponding?	N/A	N/A	Gutter Slope (%)	N/A
N/A	Gutter Lip Ht (in)	N/A	N/A	Gutter X Slope (%)	N/A
N/A	Painted X Walk1?	No	N/A	Painted X Walk2?	N/A
	X Walk 1 Direction	To N		X Walk 2 Direction	N/A
N/A	X Walk 1 Width (in)	N/A	N/A	X Walk 2 Width (in)	N/A
	X Walk 1 Slope (%)	1.3		X Walk 2 Slope (%)	N/A
	X Walk 1 X Slope (%)	2.8		X Walk 2 X Slope (%)	N/A

N/A	Ramp inside XWalk1?	N/A	N/A	Ramp inside XWalk2?	N/A
	Road Slope (%)	N/A	N/A	Clear Space?	N/A
	Road X Slope (%)	N/A	N/A	Clear Space to XWalk (in)	N/A
N/A	Any Obstructions?	N/A	N/A	Storm Grate/Utility Hazard?	N/A
	Obstruction Type			Storm Grate/Utility Type	
		N/A			N/A
			Yes	Surface Condition? (G/P)	Good

Possible Solutions:

Remove & Replace Entire Ramp.

Total Cost: \$ 1850.00
