Access Compliance Report

Public Rights-of-Way

(Curb Ramps)

Intersection ID: 10040845	Main Street: WAKEFIELD_DR	Cross Street: N/A	Location: NE
ADA ID: EDFB94C6A5DA	Ramp Type: Perp	Initial Pass/Fail: Fail	Overall Compliance: No
Codes/Mitigation Info/Possible Solution		Field Measurements/Component Compliance	
Severity Score: 8.75

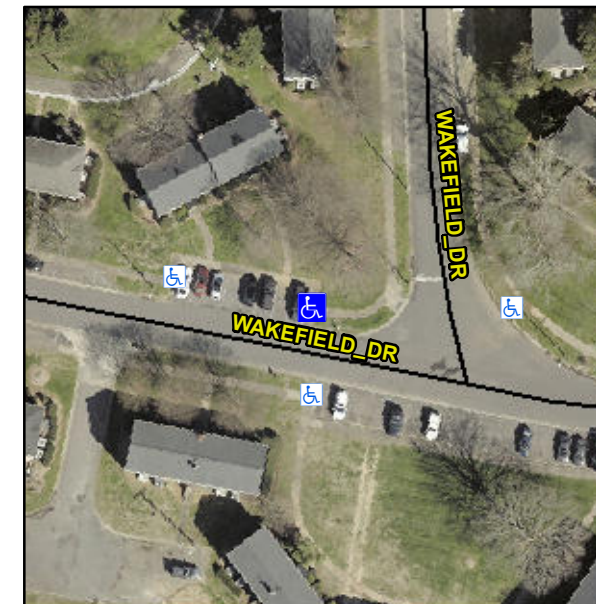
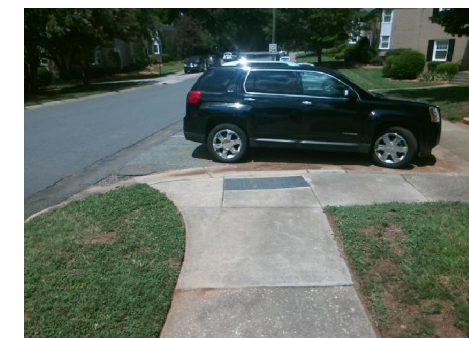
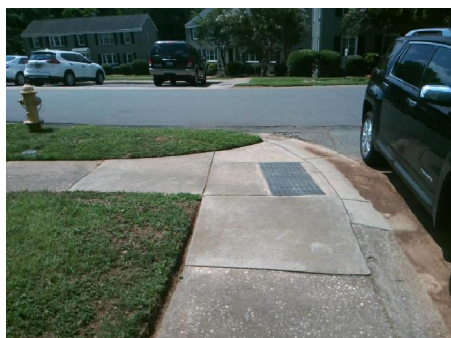
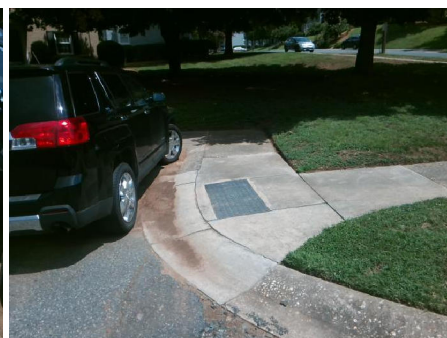
Compliance	Description	Data	Compliance	Description	Data
N/A	Ramp Length (in)	59.0	Yes	Ramp Slope (%)	6.9
No	Ramp Width (in)	47.0	Yes	Ramp XSlope (%)	1.6
N/A	Flare Type LT	N/A	N/A	Flare Type RT	N/A
N/A	Flare Slope LT (%)	N/A	N/A	Flare Slope RT (%)	N/A
N/A	Flare Traversable LT?	N/A	N/A	Flare Traversable RT?	N/A
N/A	Landing Length (in)	N/A	N/A	DWS Provided?	N/A
N/A	Landing Width (in)	N/A	N/A	DWS Contrast?	N/A
N/A	Landing Slope (%)	N/A	N/A	DWS Length (in)	N/A
N/A	Landing X Slope (%)	N/A	N/A	DWS Full Width?	N/A
N/A	Landing Curb? (Y/N)	N/A	N/A	DWS Offset (in)	N/A
N/A	Shared Landing?	N/A			
N/A	Gutter Ponding?	N/A	N/A	Gutter Slope (%)	N/A
N/A	Gutter Lip Ht (in)	N/A	N/A	Gutter X Slope (%)	N/A
N/A	Painted X Walk1?	No	N/A	Painted X Walk2?	N/A
	X Walk 1 Direction	To NW		X Walk 2 Direction	N/A
N/A	X Walk 1 Width (in)	N/A	N/A	X Walk 2 Width (in)	N/A
	X Walk 1 Slope (%)	1.8		X Walk 2 Slope (%)	N/A
	X Walk 1 X Slope (%)	1.8		X Walk 2 X Slope (%)	N/A

N/A	Ramp inside XWalk1?	N/A	N/A	Ramp inside XWalk2?	N/A
	Road Slope (%)	N/A	N/A	Clear Space?	N/A
	Road X Slope (%)	N/A	N/A	Clear Space to XWalk (in)	N/A
N/A	Any Obstructions?	N/A	N/A	Storm Grate/Utility Hazard?	N/A
	Obstruction Type			Storm Grate/Utility Type	
		N/A			N/A
			Yes	Surface Condition? (G/P)	Good

Possible Solutions:

Remove & Replace Entire Ramp.

R304.5.1
