Access Compliance Report

Public Rights-of-Way

(Curb Ramps)

Intersection ID: 7143	Main Street: HAMMONDS_ST	Cross Street: CENTERFIELD_DR	Location: E
ADA ID: EE089025BA51	Ramp Type: Perp	Initial Pass/Fail: Fail	Overall Compliance: No
		Severity Score: 8.75

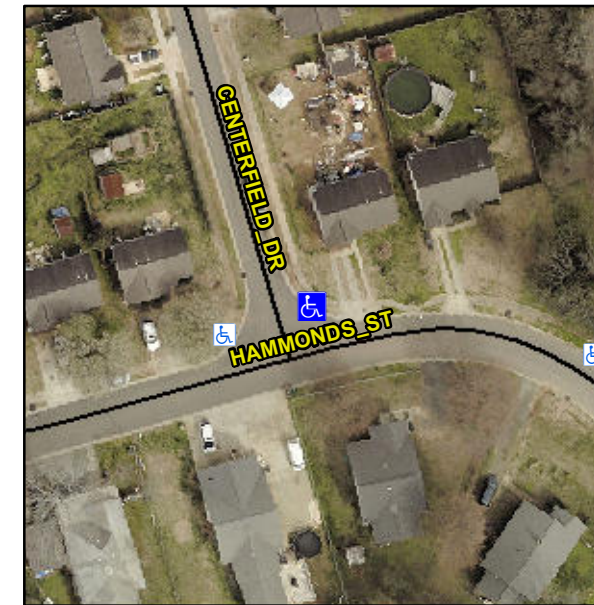
R304.5.1

Compliance	Description	Data	Compliance	Description	Data
N/A	Ramp Length (in)	48.0	Yes	Ramp Slope (%)	5.0
No	Ramp Width (in)	42.5	Yes	Ramp XSlope (%)	0.5
N/A	Flare Type LT	N/A	N/A	Flare Type RT	N/A
N/A	Flare Slope LT (%)	N/A	N/A	Flare Slope RT (%)	N/A
N/A	Flare Traversable LT?	N/A	N/A	Flare Traversable RT?	N/A
N/A	Landing Length (in)	N/A	N/A	DWS Provided?	N/A
N/A	Landing Width (in)	N/A	N/A	DWS Contrast?	N/A
N/A	Landing Slope (%)	N/A	N/A	DWS Length (in)	N/A
N/A	Landing X Slope (%)	N/A	N/A	DWS Full Width?	N/A
N/A	Landing Curb? (Y/N)	N/A	N/A	DWS Offset (in)	N/A
N/A	Shared Landing?	N/A			
N/A	Gutter Ponding?	N/A	N/A	Gutter Slope (%)	N/A
N/A	Gutter Lip Ht (in)	1.0	N/A	Gutter X Slope (%)	N/A
N/A	Painted X Walk1?	No	N/A	Painted X Walk2?	N/A
	X Walk 1 Direction	To W		X Walk 2 Direction	N/A
N/A	X Walk 1 Width (in)	N/A	N/A	X Walk 2 Width (in)	N/A
	X Walk 1 Slope (%)	2.8		X Walk 2 Slope (%)	N/A
	X Walk 1 X Slope (%)	0.3		X Walk 2 X Slope (%)	N/A

N/A	Ramp inside XWalk1?	N/A	N/A	Ramp inside XWalk2?	N/A
	Road Slope (%)	N/A	N/A	Clear Space?	N/A
	Road X Slope (%)	N/A	N/A	Clear Space to XWalk (in)	N/A
N/A	Any Obstructions?	N/A	N/A	Storm Grate/Utility Hazard?	N/A
	Obstruction Type			Storm Grate/Utility Type	
		N/A			N/A
			Yes	Surface Condition? (G/P)	Good

Remove & Replace Entire Ramp.

Total Cost: \$ 1850.00
