# Access Compliance Report

## Public Rights-of-Way

| Intersection ID: 43500 | Main Street: MCALLISTER_PARK_DR | Cross Street: WILFORD_CT | Location: S |
| ADA ID: EE142266946F | Ramp Type: PerpDiag | Initial Pass/Fail: Fail | Overall Compliance: No |

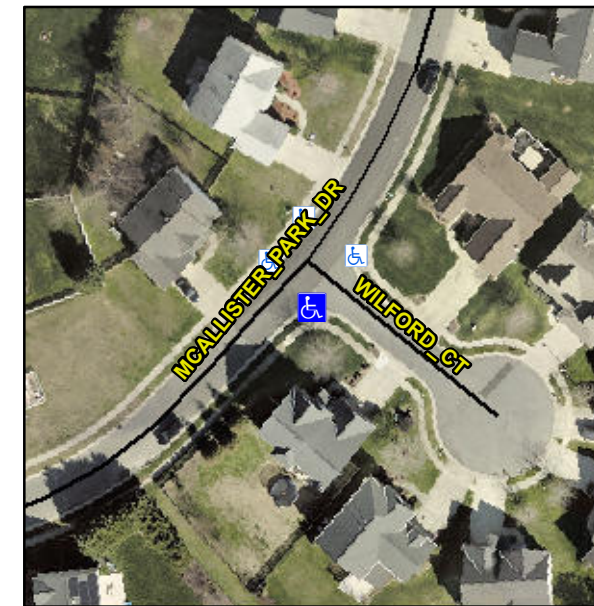
| Severity Score: 8.75 | | | |

**N/A**

**Not Found, R304.5.1**

| Compliance | Description | Data | Compliance | Description | Data |
|---|---|---|---|---|---|
| No | Ramp Width (in) | 37.5 | Yes | Ramp XSlope (%) | 0.4 |

**Remove & Replace Curb Ramp With Two New Directional Ramps or Equivalent.**

Total Cost: \$ 3200.00
