# Access Compliance Report

## Public Rights-of-Way

| Intersection ID: 10168 | Main Street: ROZZELLES_FERRY_RD | Cross Street: S_GARDNER_AV | Location: SW |
| ADA ID: EE1D89E0BB65 | Ramp Type: BlendTrans1 | Initial Pass/Fail: Pass | Overall Compliance: No |

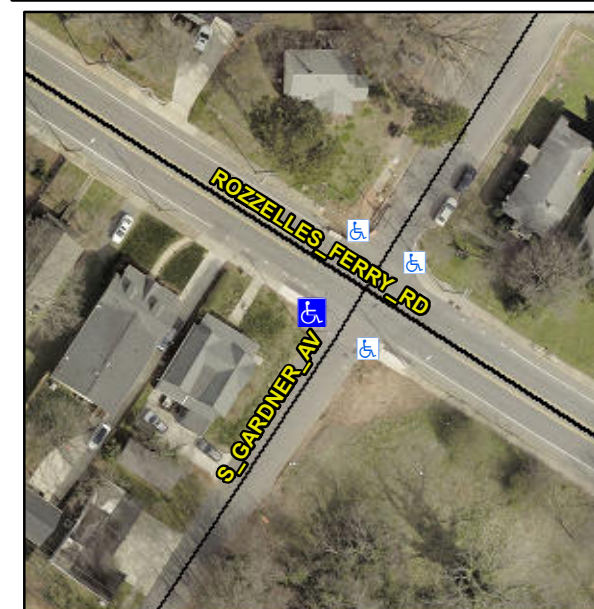
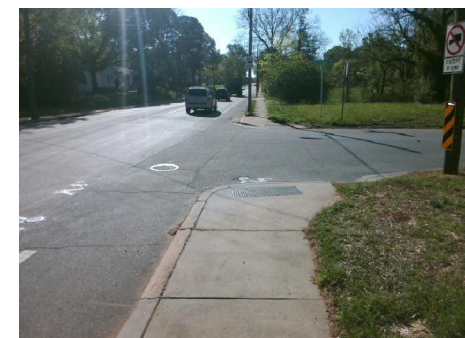
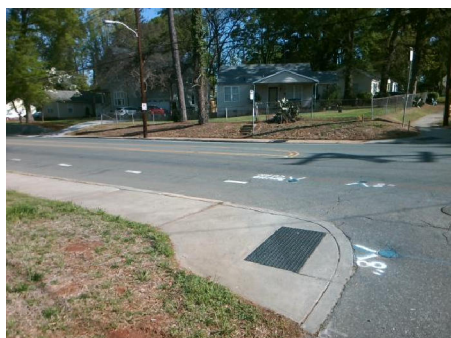
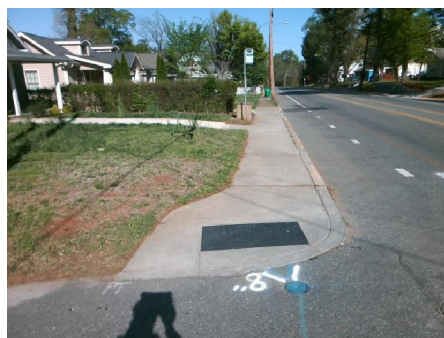
**R304.5.3, R304.2.2-Perp, R304.3.2-Para, R305.2**

| Compliance | Description | Data | Compliance | Description | Data |
|---|---|---|---|---|---|
| Yes | Ramp Width (in) | 48.0 | No | BlendTrans XSlope (%) | 2.2 |
| No | Landing Slope (%) | 2.2 | Yes | DWS Length (in) | 24.5 |
| No | Landing X Slope (%) | 2.1 | Yes | DWS Full Width? | Yes |
| N/A | Landing Curb? (Y/N) | No | No | DWS Offset (in) | 13.0 |
| Yes | Gutter Lip Ht (in) | 0.0 | No | Gutter X Slope (%) | 3.2 |

**Remove & Replace Curb Ramp With Two New Directional Ramps or Equivalent. Remove & Replace Gutter.**

Total Cost: \$ 3950.00
