# Access Compliance Report

## Public Rights-of-Way

### (Curb Ramps)

Intersection ID: 6943	Main Street: BEATTIES_FORD_RD	Cross Street: CINDY_LN	Location: NW
ADA ID: EE236DFC7A49	Ramp Type: PerpDiag	Initial Pass/Fail: Fail	Overall Compliance: No
Severity Score: 46.25			
Codes/Mitigation Info/Possible Solution		Field Measurements/Component Compliance

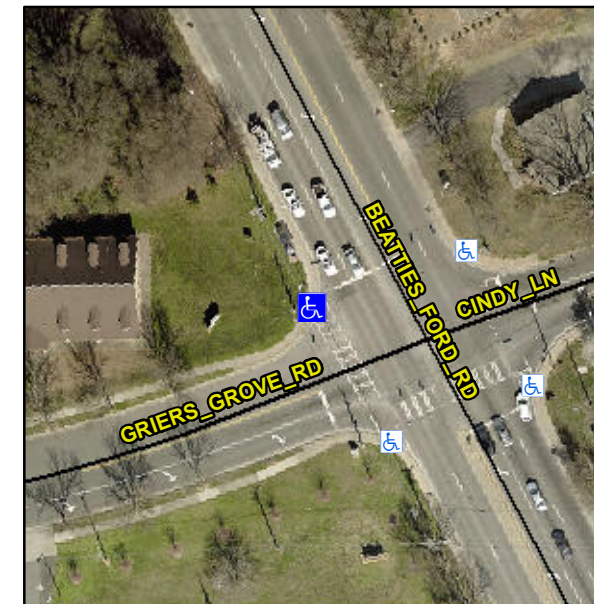
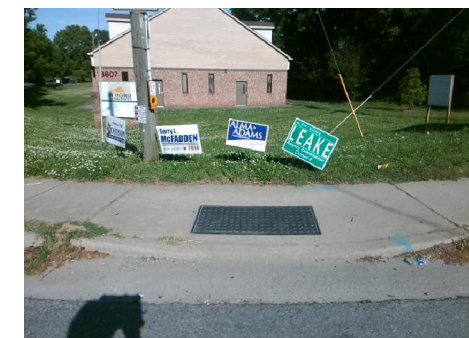
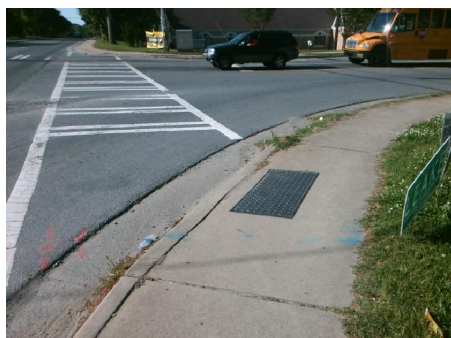
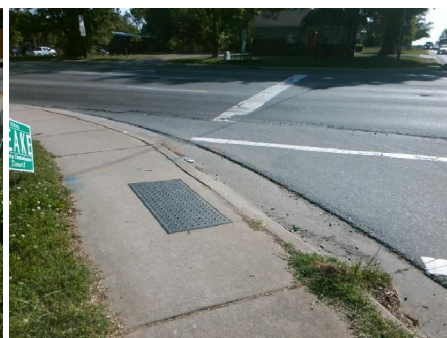
**Not Found, R304.5.1, R304.2.2, R304.5.3**

Compliance	Description	Data	Compliance	Description	Data
N/A	Ramp Length (in)	56.0	No	Ramp Slope (%)	9.3
No	Ramp Width (in)	44.0	No	Ramp XSlope (%)	7.9
N/A	Flare Type LT	N/A	N/A	Flare Type RT	N/A
N/A	Flare Slope LT (%)	N/A	N/A	Flare Slope RT (%)	N/A
N/A	Flare Traversable LT?	N/A	N/A	Flare Traversable RT?	N/A
N/A	Landing Length (in)	N/A	N/A	DWS Provided?	N/A
N/A	Landing Width (in)	N/A	N/A	DWS Contrast?	N/A
N/A	Landing Slope (%)	N/A	N/A	DWS Length (in)	N/A
N/A	Landing X Slope (%)	N/A	N/A	DWS Full Width?	N/A
N/A	Landing Curb? (Y/N)	N/A	N/A	DWS Offset (in)	N/A
N/A	Shared Landing?	N/A			
N/A	Gutter Ponding?	N/A	N/A	Gutter Slope (%)	N/A
N/A	Gutter Lip Ht (in)	1.0	N/A	Gutter X Slope (%)	N/A
N/A	Painted X Walk1?	Yes	N/A	Painted X Walk2?	No
	X Walk 1 Direction	To S		X Walk 2 Direction	To E
N/A	X Walk 1 Width (in)	110.0	N/A	X Walk 2 Width (in)	N/A
	X Walk 1 Slope (%)	0.9		X Walk 2 Slope (%)	3.5
	X Walk 1 X Slope (%)	2.2		X Walk 2 X Slope (%)	0.5

N/A	Ramp inside XWalk1?	Yes	N/A	Ramp inside XWalk2?	N/A
	Road Slope (%)	2.2	N/A	Clear Space?	N/A
	Road X Slope (%)	0.7	N/A	Clear Space to XWalk (in)	N/A
N/A	Any Obstructions?	N/A	N/A	Storm Grate/Utility Hazard?	N/A
	Obstruction Type			Storm Grate/Utility Type	
		N/A			N/A
		Yes		Surface Condition? (G/P)	Good

**Remove & Replace Curb Ramp With Two New Directional Ramps or Equivalent.**

Total Cost: \$ 3200.00
