Access Compliance Report

Public Rights-of-Way

(Curb Ramps)

Intersection ID: 8967	Main Street: BRADFORD_DR	Cross Street: LYNN_ST	Location: SE
ADA ID: EE290803D04F	Ramp Type: PerpDiag	Initial Pass/Fail: Fail	Overall Compliance: No
Codes/Mitigation Info/Possible Solution			Severity Score: 25
			Field Measurements/Component Compliance

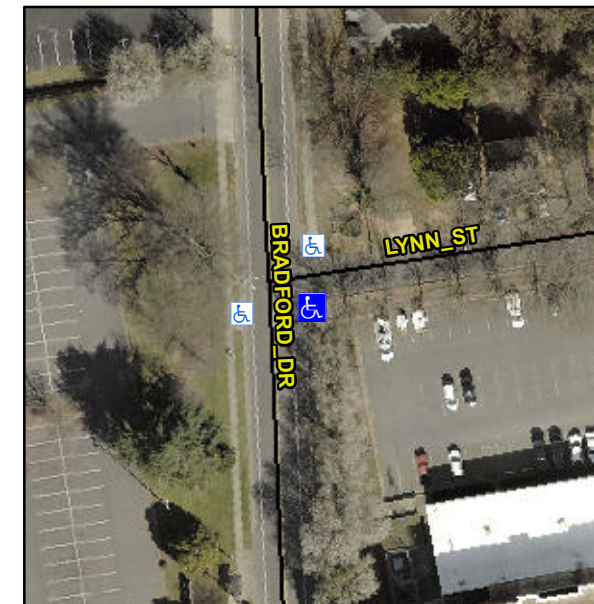
Not Found, R304.5.3

Compliance	Description	Data	Compliance	Description	Data
N/A	Ramp Length (in)	53.0	Yes	Ramp Slope (%)	5.8
Yes	Ramp Width (in)	48.0	No	Ramp XSlope (%)	10.7
N/A	Flare Type LT	N/A	N/A	Flare Type RT	N/A
N/A	Flare Slope LT (%)	N/A	N/A	Flare Slope RT (%)	N/A
N/A	Flare Traversable LT?	N/A	N/A	Flare Traversable RT?	N/A
N/A	Landing Length (in)	N/A	N/A	DWS Provided?	N/A
N/A	Landing Width (in)	N/A	N/A	DWS Contrast?	N/A
N/A	Landing Slope (%)	N/A	N/A	DWS Length (in)	N/A
N/A	Landing X Slope (%)	N/A	N/A	DWS Full Width?	N/A
N/A	Landing Curb? (Y/N)	N/A	N/A	DWS Offset (in)	N/A
N/A	Shared Landing?	N/A			
N/A	Gutter Ponding?	N/A	N/A	Gutter Slope (%)	N/A
N/A	Gutter Lip Ht (in)	N/A	N/A	Gutter X Slope (%)	N/A
N/A	Painted X Walk1?	No	N/A	Painted X Walk2?	No
	X Walk 1 Direction	To N		X Walk 2 Direction	To W
N/A	X Walk 1 Width (in)	N/A	N/A	X Walk 2 Width (in)	N/A
	X Walk 1 Slope (%)	4.5		X Walk 2 Slope (%)	9.5
	X Walk 1 X Slope (%)	7.6		X Walk 2 X Slope (%)	2.9

N/A	Ramp inside XWalk1?	N/A	N/A	Ramp inside XWalk2?	N/A
	Road Slope (%)	10.0	N/A	Clear Space?	N/A
	Road X Slope (%)	6.8	N/A	Clear Space to XWalk (in)	N/A
N/A	Any Obstructions?	N/A	N/A	Storm Grate/Utility Hazard?	N/A
	Obstruction Type			Storm Grate/Utility Type	
		N/A			N/A
			Yes	Surface Condition? (G/P)	Good

Remove & Replace Curb Ramp With Two New Directional Ramps or Equivalent.
