# Access Compliance Report

## Public Rights-of-Way

Intersection ID: 16940	Main Street: JERILYN_DR	Cross Street: MONROE_RD	Location: N
ADA ID: EE2D056A21A7	Ramp Type: PerpDiag	Initial Pass/Fail: Fail	Overall Compliance: No
			Severity Score: 18.75

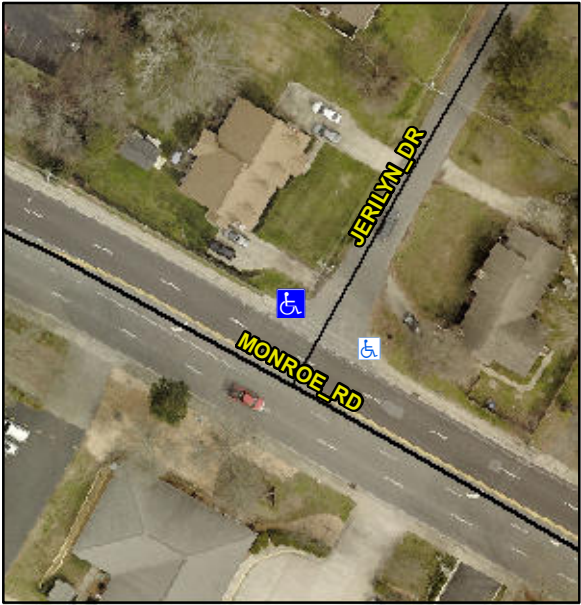
Possible Solutions:		<b>Compliance</b>	<b>Description</b>	<b>Data</b>
	<b>Remove &amp; Replace Curb Ramp With Two New Directional Ramps or Equivalent.</b>		<b>Yes</b>	Ramp Length (in)	59.0
			<b>No</b>	Ramp Width (in)	35.0
			<b>N/A</b>	Flare Type LT	N/A
			<b>N/A</b>	Flare Slope LT (%)	N/A
			<b>N/A</b>	Flare Traversable LT?	N/A
			<b>N/A</b>	Landing Length (in)	N/A
			<b>N/A</b>	Landing Width (in)	N/A
			<b>N/A</b>	Landing Slope (%)	N/A
			<b>N/A</b>	Landing X Slope (%)	N/A
<p>Surveyor Notes:</p> <p><b>N/A</b></p> <p>PROW/ADA:</p> <p><b>R304.5.1, R304.5.3</b></p>			<b>N/A</b>	Flare Type RT	N/A
			<b>N/A</b>	Flare Slope RT (%)	N/A
			<b>N/A</b>	Flare Traversable RT?	N/A
			<b>N/A</b>	DWS Provided?	N/A
			<b>N/A</b>	DWS Contrast?	N/A
			<b>N/A</b>	DWS Length (in)	N/A
			<b>N/A</b>	DWS Full Width?	N/A
			<b>N/A</b>	DWS Offset (in)	N/A

<b>N/A</b>	Gutter Ponding?	N/A
			<b>N/A</b>	Gutter Lip Ht (in)	N/A
<p>Total Cost:</p> <p><b>\$ 3200.00</b></p>			<b>No</b>	Painted X Walk1?	N/A
				X Walk 1 Direction	To SW
			<b>N/A</b>	X Walk 1 Width (in)	N/A
				X Walk 1 Slope (%)	2.2
				X Walk 1 X Slope (%)	2.8
			<b>N/A</b>	Ramp inside XWalk1?	N/A
				Road Slope (%)	3.8
				Road X Slope (%)	1.3
			<b>N/A</b>	Any Obstructions?	N/A
				Obstruction Type	
			<b>N/A</b>	Storm Grate/Utility Hazard?	N/A
				Storm Grate/Utility Type	
			<b>N/A</b>		N/A
			<b>Yes</b>	Surface Condition? (G/P)	Good
