# Access Compliance Report

## Public Rights-of-Way

### (Curb Ramps)

Intersection ID: 10021320	Main Street: BLAKENEY GREENS BV	Cross Street: N/A	Location: SE
ADA ID: EE3DC48D49D6	Ramp Type: PerpDiag	Initial Pass/Fail: Fail	Overall Compliance: No
		Severity Score: 12.5

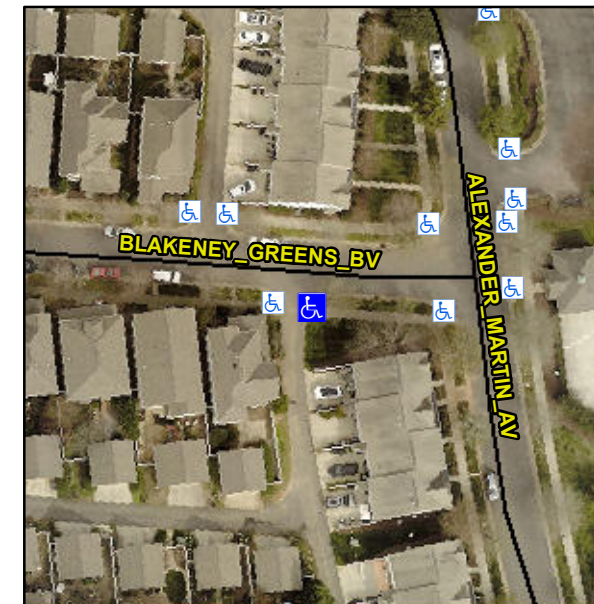
Compliance	Description	Data	Compliance	Description	Data
N/A	Ramp Length (in)	90.0	No	Ramp Slope (%)	8.7
Yes	Ramp Width (in)	49.0	Yes	Ramp XSlope (%)	0.9
N/A	Flare Type LT	N/A	N/A	Flare Type RT	N/A
N/A	Flare Slope LT (%)	N/A	N/A	Flare Slope RT (%)	N/A
N/A	Flare Traversable LT?	N/A	N/A	Flare Traversable RT?	N/A
N/A	Landing Length (in)	N/A	N/A	DWS Provided?	N/A
N/A	Landing Width (in)	N/A	N/A	DWS Contrast?	N/A
N/A	Landing Slope (%)	N/A	N/A	DWS Length (in)	N/A
N/A	Landing X Slope (%)	N/A	N/A	DWS Full Width?	N/A
N/A	Landing Curb? (Y/N)	N/A	N/A	DWS Offset (in)	N/A
N/A	Shared Landing?	N/A			
N/A	Gutter Ponding?	N/A	N/A	Gutter Slope (%)	N/A
N/A	Gutter Lip Ht (in)	N/A	N/A	Gutter X Slope (%)	N/A
N/A	Painted X Walk1?	No	N/A	Painted X Walk2?	No
	X Walk 1 Direction	To N		X Walk 2 Direction	To NW
N/A	X Walk 1 Width (in)	N/A	N/A	X Walk 2 Width (in)	N/A
	X Walk 1 Slope (%)	1.6		X Walk 2 Slope (%)	0.3
	X Walk 1 X Slope (%)	3.2		X Walk 2 X Slope (%)	0.3

N/A	Ramp inside XWalk1?	N/A	N/A	Ramp inside XWalk2?	N/A
	Road Slope (%)	1.6	N/A	Clear Space?	N/A
	Road X Slope (%)	1.6	N/A	Clear Space to XWalk (in)	N/A
N/A	Any Obstructions?	N/A	N/A	Storm Grate/Utility Hazard?	N/A
	Obstruction Type			Storm Grate/Utility Type	
		N/A			N/A
			Yes	Surface Condition? (G/P)	Good

**Remove & Replace Curb Ramp With Two New Directional Ramps or Equivalent.**

**Not Found, R304.2.2**
