Access Compliance Report

Public Rights-of-Way

(Curb Ramps)

Intersection ID: 12355	Main Street: MONUMENT_ST	Cross Street: GREENLAND_AV	Location: SW
ADA ID: EE57126251C8	Ramp Type: Perp	Initial Pass/Fail: Fail	Overall Compliance: No
		Severity Score: 8.75

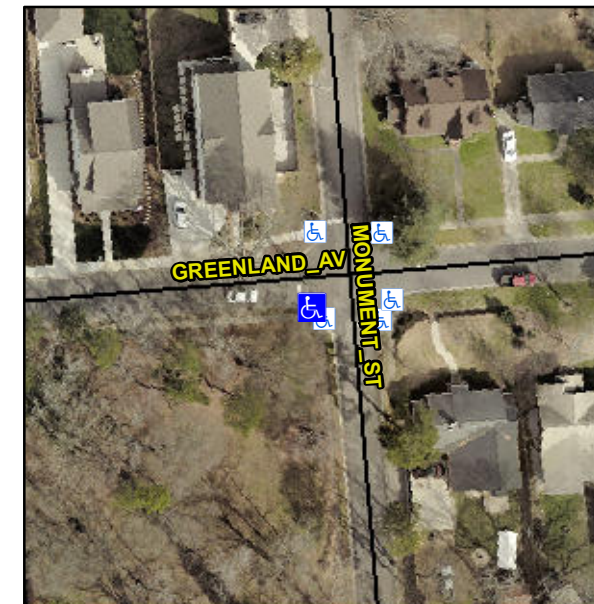
Not Found, R304.5.1

Compliance	Description	Data	Compliance	Description	Data
N/A	Ramp Length (in)	85.0	Yes	Ramp Slope (%)	5.0
No	Ramp Width (in)	47.0	Yes	Ramp XSlope (%)	0.3
N/A	Flare Type LT	N/A	N/A	Flare Type RT	N/A
N/A	Flare Slope LT (%)	N/A	N/A	Flare Slope RT (%)	N/A
N/A	Flare Traversable LT?	N/A	N/A	Flare Traversable RT?	N/A
N/A	Landing Length (in)	N/A	N/A	DWS Provided?	N/A
N/A	Landing Width (in)	N/A	N/A	DWS Contrast?	N/A
N/A	Landing Slope (%)	N/A	N/A	DWS Length (in)	N/A
N/A	Landing X Slope (%)	N/A	N/A	DWS Full Width?	N/A
N/A	Landing Curb? (Y/N)	N/A	N/A	DWS Offset (in)	N/A
N/A	Shared Landing?	N/A			
N/A	Gutter Ponding?	N/A	N/A	Gutter Slope (%)	N/A
N/A	Gutter Lip Ht (in)	N/A	N/A	Gutter X Slope (%)	N/A
N/A	Painted X Walk1?	No	N/A	Painted X Walk2?	N/A
	X Walk 1 Direction	To N		X Walk 2 Direction	N/A
N/A	X Walk 1 Width (in)	N/A	N/A	X Walk 2 Width (in)	N/A
	X Walk 1 Slope (%)	2.3		X Walk 2 Slope (%)	N/A
	X Walk 1 X Slope (%)	1.5		X Walk 2 X Slope (%)	N/A

N/A	Ramp inside XWalk1?	N/A	N/A	Ramp inside XWalk2?	N/A
	Road Slope (%)	N/A	N/A	Clear Space?	N/A
	Road X Slope (%)	N/A	N/A	Clear Space to XWalk (in)	N/A
N/A	Any Obstructions?	N/A	N/A	Storm Grate/Utility Hazard?	N/A
	Obstruction Type			Storm Grate/Utility Type	
		N/A			N/A
			Yes	Surface Condition? (G/P)	Good

Remove & Replace Entire Ramp.

Total Cost: \$ 1850.00
