Access Compliance Report

Public Rights-of-Way

(Curb Ramps)

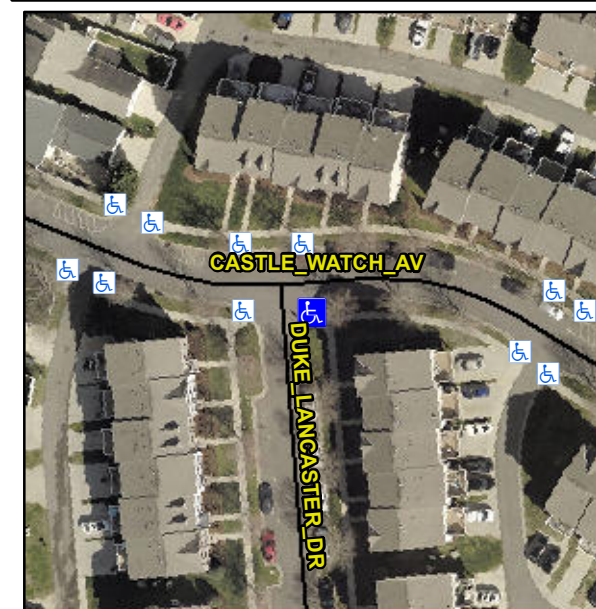
Intersection ID: 42470	Main Street: DUKE_LANCASTER_DR	Cross Street: CASTLE_WATCH_AV	Location: SE
ADA ID: EE586372FBD1	Ramp Type: PerpDiag	Initial Pass/Fail: Fail	Overall Compliance: No
Severity Score: 22.5			
Codes/Mitigation Info/Possible Solution		Field Measurements/Component Compliance

R304.5.1, R304.2.2, R304.5.3

Compliance	Description	Data	Compliance	Description	Data
N/A	Ramp Length (in)	119.0	No	Ramp Slope (%)	9.1
No	Ramp Width (in)	47.5	No	Ramp XSlope (%)	2.2
N/A	Flare Type LT	N/A	N/A	Flare Type RT	N/A
N/A	Flare Slope LT (%)	N/A	N/A	Flare Slope RT (%)	N/A
N/A	Flare Traversable LT?	N/A	N/A	Flare Traversable RT?	N/A
N/A	Landing Length (in)	N/A	N/A	DWS Provided?	N/A
N/A	Landing Width (in)	N/A	N/A	DWS Contrast?	N/A
N/A	Landing Slope (%)	N/A	N/A	DWS Length (in)	N/A
N/A	Landing X Slope (%)	N/A	N/A	DWS Full Width?	N/A
N/A	Landing Curb? (Y/N)	N/A	N/A	DWS Offset (in)	N/A
N/A	Shared Landing?	N/A			
N/A	Gutter Ponding?	N/A	N/A	Gutter Slope (%)	N/A
N/A	Gutter Lip Ht (in)	N/A	N/A	Gutter X Slope (%)	N/A
N/A	Painted X Walk1?	No	N/A	Painted X Walk2?	No
	X Walk 1 Direction	To N		X Walk 2 Direction	To W
N/A	X Walk 1 Width (in)	N/A	N/A	X Walk 2 Width (in)	N/A
	X Walk 1 Slope (%)	2.1		X Walk 2 Slope (%)	2.8
	X Walk 1 X Slope (%)	1.3		X Walk 2 X Slope (%)	2.4

N/A	Ramp inside XWalk1?	N/A	N/A	Ramp inside XWalk2?	N/A
	Road Slope (%)	2.4	N/A	Clear Space?	N/A
	Road X Slope (%)	0.4	N/A	Clear Space to XWalk (in)	N/A
N/A	Any Obstructions?	N/A	N/A	Storm Grate/Utility Hazard?	N/A
	Obstruction Type			Storm Grate/Utility Type	
		N/A			N/A
			Yes	Surface Condition? (G/P)	Good

Possible Solutions:

Remove & Replace Curb Ramp With Two New Directional Ramps or Equivalent.
