Access Compliance Report

Public Rights-of-Way

(Curb Ramps)

Intersection ID: 52288	Main Street: STEELE_CREEK_RD	Cross Street: DIXIE_RIVER_RD	Location: W
ADA ID: EE5BCE9F5ED8	Ramp Type: Para	Initial Pass/Fail: Pass	Overall Compliance: No
		Severity Score: 0

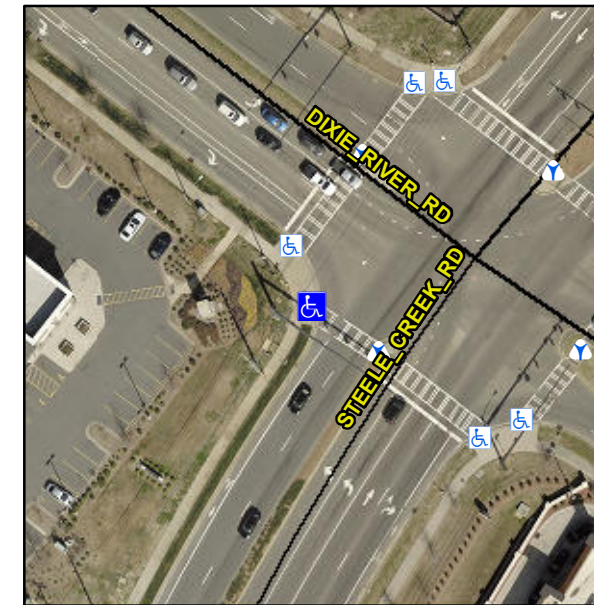
Compliance	Description	Data	Compliance	Description	Data
N/A	Ramp Length LT (in)	61.0	N/A	Ramp Length RT (in)	59.0
Yes	Ramp Width LT (in)	72.0	Yes	Ramp Width RT (in)	72.0
Yes	Ramp Slope LT (%)	6.1	Yes	Ramp Slope RT (%)	6.4
Yes	Ramp XSlope LT (%)	1.7	Yes	Ramp XSlope RT (%)	1.3
Yes	Landing Length (in)	70.0	Yes	DWS Provided?	Yes
No	Landing Width (in)	46.0	Yes	DWS Contrast?	Yes
Yes	Landing Slope (%)	0.8	Yes	DWS Length (in)	24.0
No	Landing X Slope (%)	2.2	Yes	DWS Full Width?	Yes
N/A	Landing Curb? (Y/N)	No	Yes	DWS Offset (in)	2.0
N/A	Shared Landing?	No			
Yes	Gutter Ponding?	No	Yes	Gutter Slope (%)	0.1
Yes	Gutter Lip Ht (in)	0.0	Yes	Gutter X Slope (%)	0.6
N/A	Painted X Walk1?	Yes	N/A	Painted X Walk2?	N/A
	X Walk 1 Direction	To SE		X Walk 2 Direction	N/A
N/A	X Walk 1 Width (in)	112.0	N/A	X Walk 2 Width (in)	N/A
	X Walk 1 Slope (%)	0.5		X Walk 2 Slope (%)	N/A
	X Walk 1 X Slope (%)	0.9		X Walk 2 X Slope (%)	N/A
Yes	Ramp inside XWalk1?	Yes	N/A	Ramp inside XWalk2?	N/A

Road Slope (%)	N/A	N/A	Clear Space?	Yes
	Road X Slope (%)	N/A	N/A	Clear Space to XWalk (in)	N/A
Yes	Any Obstructions?	No	Yes	Storm Grate/Utility Hazard?	No
	Obstruction Type			Storm Grate/Utility Type	
		N/A			N/A
			Yes	Surface Condition? (G/P)	Good
			Compliant	Curb Slope (%)	2.7

Possible Solutions:

Remove & Replace Landing.

R304.2.1, R304.5.3
