# Access Compliance Report

## Public Rights-of-Way

### (Curb Ramps)

Intersection ID: 30230	Main Street: MONTBROOK_DR	Cross Street: MORNINGSIDE_RD	Location:	N
ADA ID: EE5E5CB0E5D7	Ramp Type: Perp	Initial Pass/Fail: Fail	Overall Compliance: No	Severity Score: 1.25
Codes/Mitigation Info/Possible Solution		Field Measurements/Component Compliance

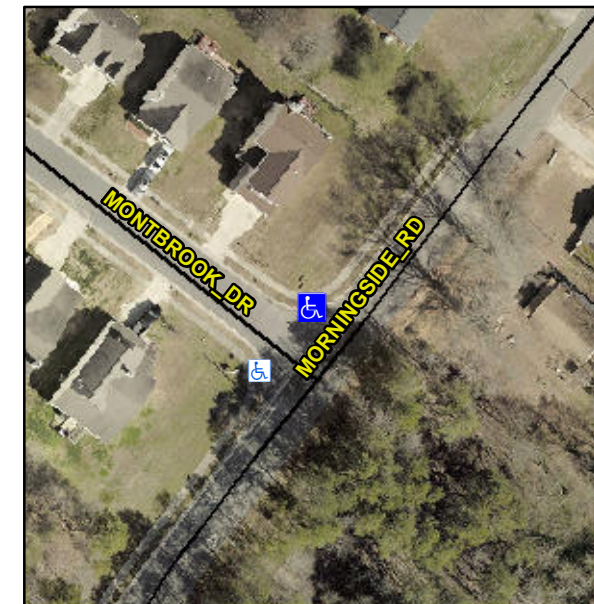
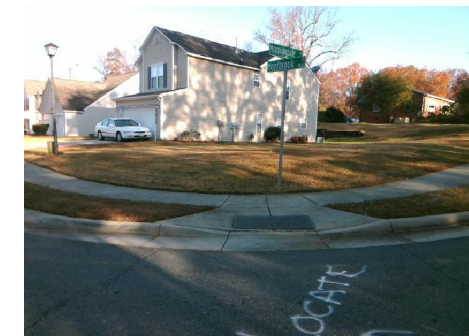
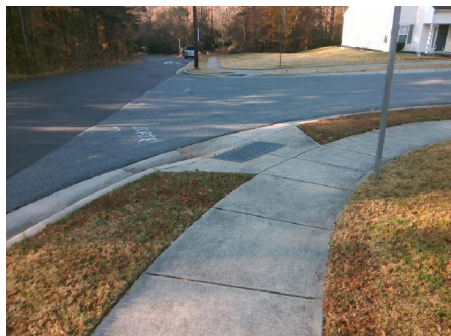
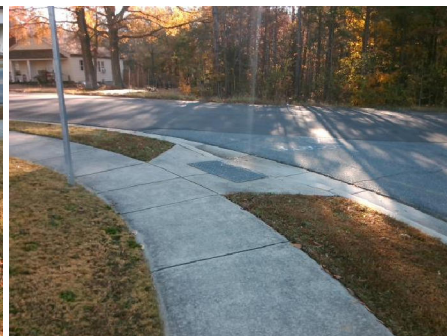
**Not Found, R304.5.3**

Compliance	Description	Data	Compliance	Description	Data
N/A	Ramp Length (in)	46.5	Yes	Ramp Slope (%)	8.1
Yes	Ramp Width (in)	49.0	No	Ramp XSlope (%)	4.0
N/A	Flare Type LT	N/A	N/A	Flare Type RT	N/A
N/A	Flare Slope LT (%)	N/A	N/A	Flare Slope RT (%)	N/A
N/A	Flare Traversable LT?	N/A	N/A	Flare Traversable RT?	N/A
N/A	Landing Length (in)	N/A	N/A	DWS Provided?	N/A
N/A	Landing Width (in)	N/A	N/A	DWS Contrast?	N/A
N/A	Landing Slope (%)	N/A	N/A	DWS Length (in)	N/A
N/A	Landing X Slope (%)	N/A	N/A	DWS Full Width?	N/A
N/A	Landing Curb? (Y/N)	N/A	N/A	DWS Offset (in)	N/A
N/A	Shared Landing?	N/A			
N/A	Gutter Ponding?	N/A	N/A	Gutter Slope (%)	N/A
N/A	Gutter Lip Ht (in)	0.5	N/A	Gutter X Slope (%)	N/A
N/A	Painted X Walk1?	No	N/A	Painted X Walk2?	N/A
	X Walk 1 Direction	To SW		X Walk 2 Direction	N/A
N/A	X Walk 1 Width (in)	N/A	N/A	X Walk 2 Width (in)	N/A
	X Walk 1 Slope (%)	3.8		X Walk 2 Slope (%)	N/A
	X Walk 1 X Slope (%)	2.1		X Walk 2 X Slope (%)	N/A

N/A	Ramp inside XWalk1?	N/A	N/A	Ramp inside XWalk2?	N/A
	Road Slope (%)	N/A	N/A	Clear Space?	N/A
	Road X Slope (%)	N/A	N/A	Clear Space to XWalk (in)	N/A
N/A	Any Obstructions?	N/A	N/A	Storm Grate/Utility Hazard?	N/A
	Obstruction Type			Storm Grate/Utility Type	
		N/A			N/A
			Yes	Surface Condition? (G/P)	Good

**Remove & Replace Entire Ramp.**

Total Cost: \$ 1850.00
