# Access Compliance Report

## Public Rights-of-Way

### (Curb Ramps)

Intersection ID: 12613	Main Street: E_TRADE_ST	Cross Street: S_BREVARD_ST	Location: SW
ADA ID: EE657E8C3284	Ramp Type: Perp	Initial Pass/Fail: Pass	Overall Compliance: No
Severity Score: 0.25			
Codes/Mitigation Info/Possible Solution		Field Measurements/Component Compliance

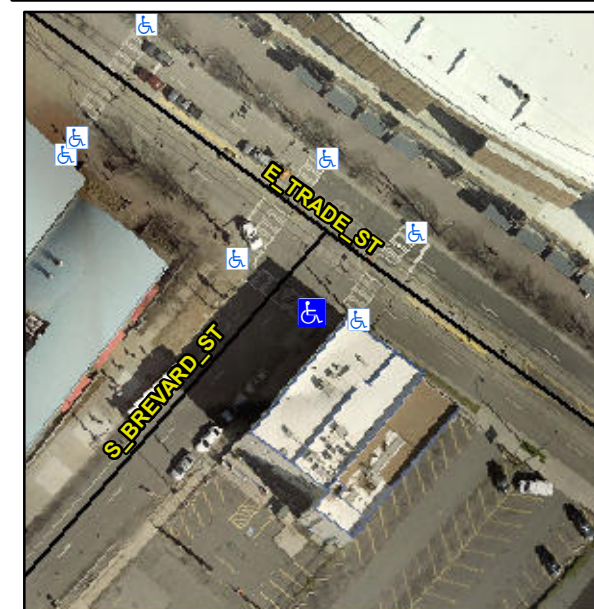
**SLOPES VERIFIED & MATCH**

**Not Found, R304.5.3, R304.2.2-Perp, R304.3.2-Para**

Compliance	Description	Data	Compliance	Description	Data
N/A	Ramp Length (in)	44.0	Yes	Ramp Slope (%)	7.7
Yes	Ramp Width (in)	48.0	No	Ramp XSlope (%)	2.1
N/A	Flare Type LT	Sloped	N/A	Flare Type RT	N/A
N/A	Flare Slope LT (%)	7.3	Yes	Flare Slope RT (%)	4.5
N/A	Flare Traversable LT?	Yes	N/A	Flare Traversable RT?	Yes
Yes	Landing Length (in)	48.0	Yes	DWS Provided?	Yes
Yes	Landing Width (in)	48.0	Yes	DWS Contrast?	Yes
No	Landing Slope (%)	2.1	Yes	DWS Length (in)	24.0
Yes	Landing X Slope (%)	1.6	Yes	DWS Full Width?	Yes
N/A	Landing Curb? (Y/N)	No	Yes	DWS Offset (in)	1.0
N/A	Shared Landing?	No			
Yes	Gutter Ponding?	No	Yes	Gutter Slope (%)	1.3
Yes	Gutter Lip Ht (in)	0.0	Yes	Gutter X Slope (%)	1.1
N/A	Painted X Walk1?	Yes	N/A	Painted X Walk2?	N/A
	X Walk 1 Direction	To NW		X Walk 2 Direction	N/A
N/A	X Walk 1 Width (in)	117.0	N/A	X Walk 2 Width (in)	N/A
	X Walk 1 Slope (%)	0.4		X Walk 2 Slope (%)	N/A
	X Walk 1 X Slope (%)	1.7		X Walk 2 X Slope (%)	N/A

Yes	Ramp inside XWalk1?	Yes	N/A	Ramp inside XWalk2?	N/A
	Road Slope (%)	N/A	N/A	Clear Space?	Yes
	Road X Slope (%)	N/A	N/A	Clear Space to XWalk (in)	N/A
Yes	Any Obstructions?	No	Yes	Storm Grate/Utility Hazard?	No
	Obstruction Type			Storm Grate/Utility Type	
		N/A			N/A
			Yes	Surface Condition? (G/P)	Good

Possible Solutions:

**Remove & Replace Entire Ramp.**

Total Cost: \$ 1850.00

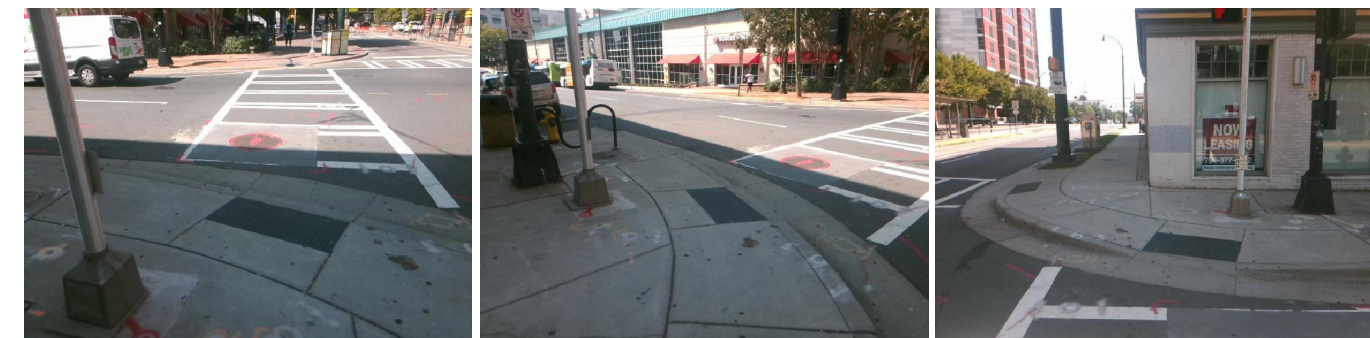
Street 1 Name	S BREVARD ST
Stop Condition-Street 2	Signal
Street 2 Name	N/A
Stop Condition-Street 1	N/A
