# Access Compliance Report

## Public Rights-of-Way

### (Curb Ramps)

| Intersection ID: 19543 | Main Street: SCOFIELD_RD | Cross Street: TOPPING_PL | Location: S |

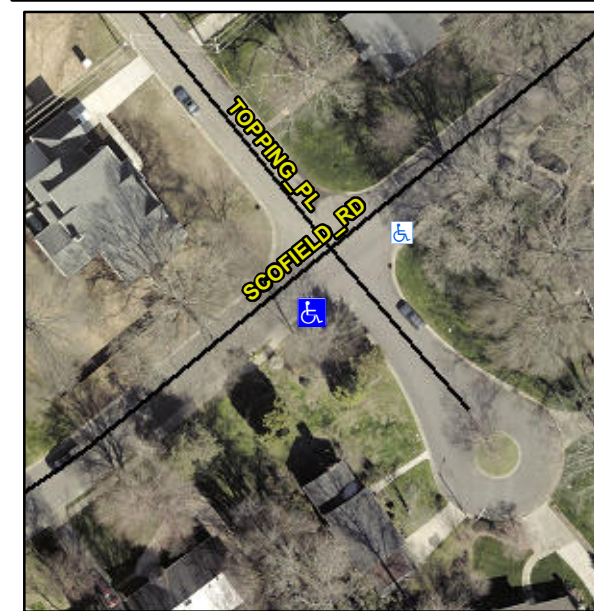
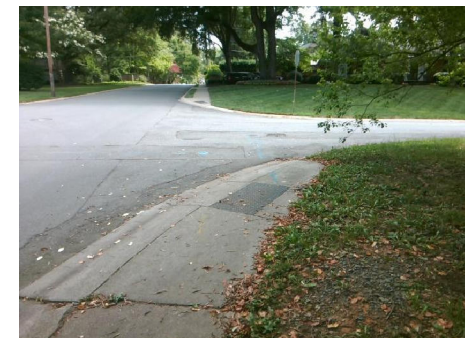
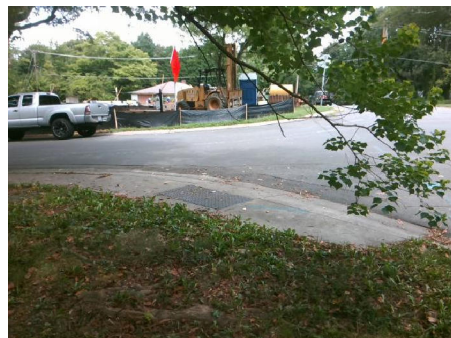
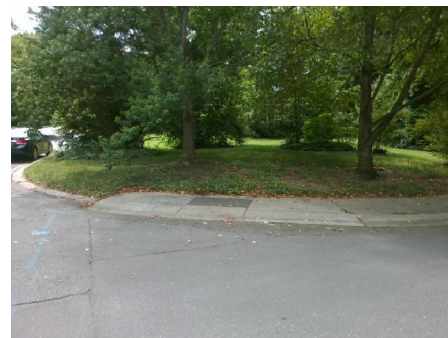
| ADA ID: EE68D406176D | Ramp Type: BlendTrans2 | Initial Pass/Fail: Pass | Overall Compliance: No |

**Not Found, R304.5.3, R304.2.3**

| Compliance | Description | Data | Compliance | Description | Data |
|---|---|---|---|---|---|
| Yes | Ramp Width (in) | 48.0 | No | BlendTrans XSlope (%) | 2.3 |
| N/A | Flare Slope LT (%) | N/A | No | Flare Slope RT (%) | N/A |
| | | | No | Curb Slope (%) | 8.6 |

**Remove & Replace Curb Ramp With Two New Directional Ramps or Equivalent.**

Total Cost: \$ 3200.00
