Access Compliance Report

Public Rights-of-Way

(Curb Ramps)

Intersection ID: 31878	Main Street: LANGDEN_GATE_DR	Cross Street: WILLIAMS_GLENN_RD	Location: NE
ADA ID: EE722851F755	Ramp Type: PerpDiag	Initial Pass/Fail: Fail	Overall Compliance: No
Severity Score: 10			
Codes/Mitigation Info/Possible Solution		Field Measurements/Component Compliance

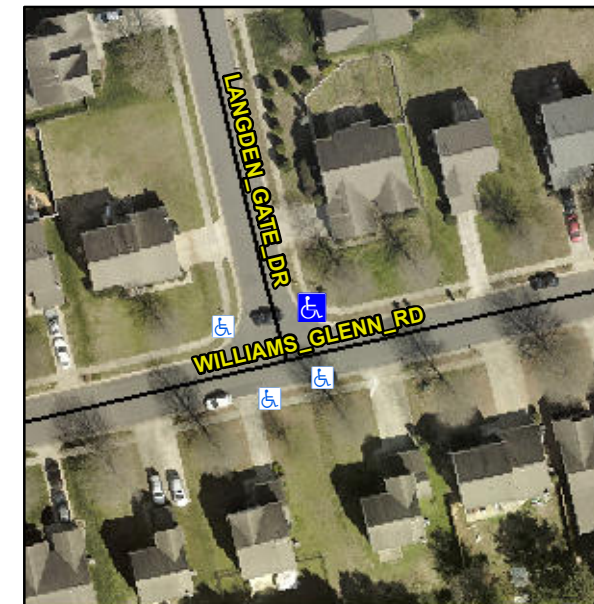
Compliance	Description	Data	Compliance	Description	Data
N/A	Ramp Length (in)	47.0	Yes	Ramp Slope (%)	7.8
No	Ramp Width (in)	43.0	No	Ramp XSlope (%)	2.9
N/A	Flare Type LT	N/A	N/A	Flare Type RT	N/A
N/A	Flare Slope LT (%)	N/A	N/A	Flare Slope RT (%)	N/A
N/A	Flare Traversable LT?	N/A	N/A	Flare Traversable RT?	N/A
N/A	Landing Length (in)	N/A	N/A	DWS Provided?	N/A
N/A	Landing Width (in)	N/A	N/A	DWS Contrast?	N/A
N/A	Landing Slope (%)	N/A	N/A	DWS Length (in)	N/A
N/A	Landing X Slope (%)	N/A	N/A	DWS Full Width?	N/A
N/A	Landing Curb? (Y/N)	N/A	N/A	DWS Offset (in)	N/A
N/A	Shared Landing?	N/A			
N/A	Gutter Ponding?	N/A	N/A	Gutter Slope (%)	N/A
N/A	Gutter Lip Ht (in)	N/A	N/A	Gutter X Slope (%)	N/A
N/A	Painted X Walk1?	No	N/A	Painted X Walk2?	No
	X Walk 1 Direction	To W		X Walk 2 Direction	To S
N/A	X Walk 1 Width (in)	N/A	N/A	X Walk 2 Width (in)	N/A
	X Walk 1 Slope (%)	2.3		X Walk 2 Slope (%)	0.3
	X Walk 1 X Slope (%)	0.6		X Walk 2 X Slope (%)	2.5

N/A	Ramp inside XWalk1?	N/A	N/A	Ramp inside XWalk2?	N/A
	Road Slope (%)	0.5	N/A	Clear Space?	N/A
	Road X Slope (%)	1.8	N/A	Clear Space to XWalk (in)	N/A
N/A	Any Obstructions?	N/A	N/A	Storm Grate/Utility Hazard?	N/A
	Obstruction Type			Storm Grate/Utility Type	
		N/A			N/A
			Yes	Surface Condition? (G/P)	Good

Remove & Replace Curb Ramp With Two New Directional Ramps or Equivalent.

R304.5.1, R304.5.3
