Access Compliance Report

Public Rights-of-Way

(Curb Ramps)

Intersection ID: 15689	Main Street: MCDONALD_AV	Cross Street: PARK_RD	Location: SW
ADA ID: EE7EC390ED1F	Ramp Type: Directional1	Initial Pass/Fail: Fail	Overall Compliance: No
		Severity Score: 10

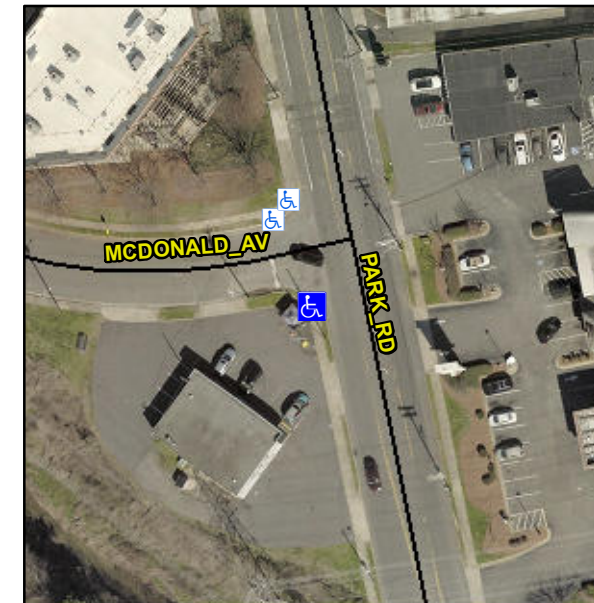
XWWALK FADED

R304.5.1, R304.5.3

Compliance	Description	Data	Compliance	Description	Data
N/A	Ramp Length (in)	28.0	N/A	Grade Break?	N/A
No	Ramp Width (in)	39.0	N/A	Grade Break Slope (%)	0.0
Yes	Ramp Slope (%)	4.4	N/A	Grade Break XSlope (%)	0.0
No	Ramp XSlope (%)	3.0			
N/A	Flare Type LT	N/A	N/A	Flare Type RT	N/A
N/A	Flare Slope LT (%)	N/A	N/A	Flare Slope RT (%)	0.0
N/A	Flare Traversable LT?	N/A	N/A	Flare Traversable RT?	N/A
N/A	Landing Length (in)	0.0	N/A	DWS Provided?	N/A
N/A	Landing Width (in)	0.0	N/A	DWS Contrast?	N/A
N/A	Landing Slope (%)	0.0	N/A	DWS Length (in)	N/A
N/A	Landing X Slope (%)	0.0	N/A	DWS Full Width?	N/A
N/A	Landing Curb? (Y/N)	N/A	N/A	DWS Offset LT (in)	N/A
N/A	Shared Landing?	N/A	N/A	DWS Offset RT (in)	N/A
N/A	Gutter Ponding?	0.0	N/A	Gutter Slope (%)	N/A
N/A	Gutter Lip Ht (in)	1.0	N/A	Gutter X Slope (%)	N/A
N/A	Painted X Walk1?	No		Road Slope (%)	2.4
	X Walk 1 Direction	To NW		Road X Slope (%)	0.8
	X Walk 1 Width (in)	N/A		Clear Space?	N/A

X Walk 1 Slope (%)	2.4	N/A	Clear Space to XWalk (in)	N/A
	X Walk 1 X Slope (%)	0.8	N/A	Storm Grate/Utility Hazard?	N/A
N/A	Ramp inside XWalk1?	N/A		Storm Grate/Utility Type	
N/A	Any Obstructions?	N/A			N/A
	Obstruction Type		Yes	Surface Condition? (G/P)	Good
			N/A	Curb Slope (%)	1.8

Possible Solutions:

Remove & Replace Entire Ramp.
