# Access Compliance Report

## Public Rights-of-Way

### (Curb Ramps)

Intersection ID: 10031176	Main Street: MARK_PL	Cross Street: N/A	Location:	N
ADA ID: EE81C80F4E57	Ramp Type: BlendTrans1	Initial Pass/Fail: Fail	Overall Compliance: No	Severity Score: 25

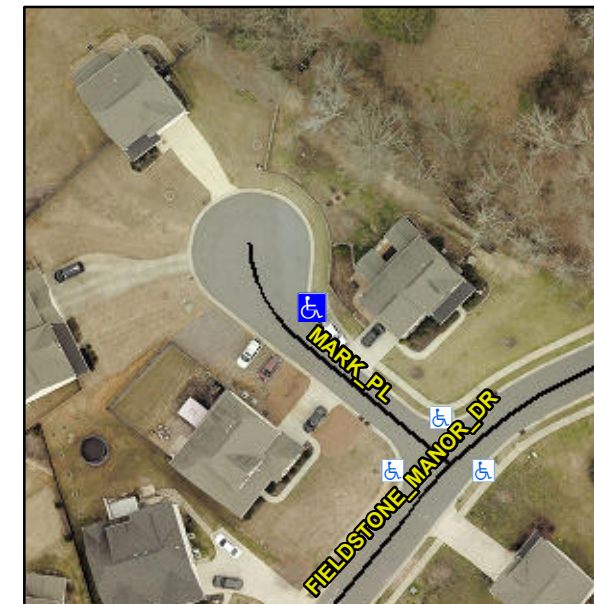
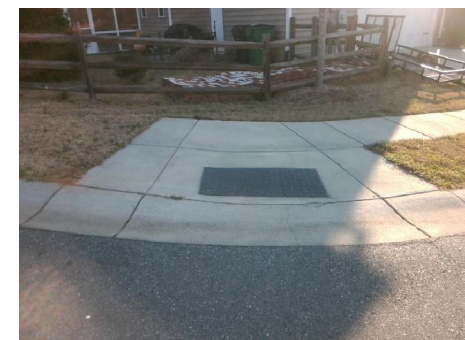
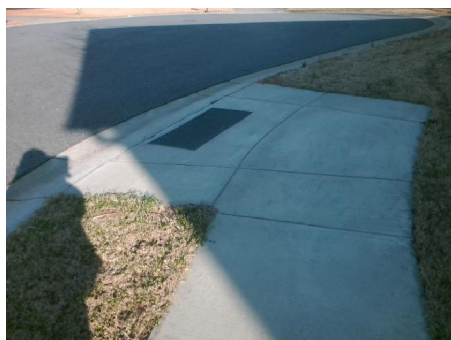
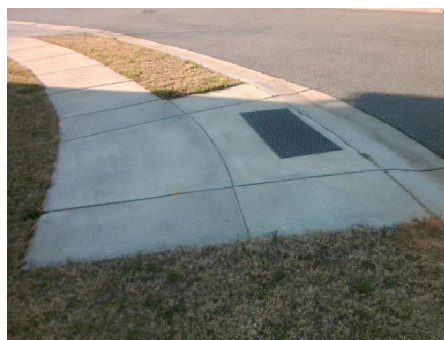
**Not Found, R304.5.3**

Compliance	Description	Data	Compliance	Description	Data
N/A	Ramp Length (in)	47.5	Yes	BlendTrans Slope (%)	4.4
Yes	Ramp Width (in)	69.0	No	BlendTrans XSlope (%)	9.2
N/A	Flare Type LT	N/A	N/A	Flare Type RT	N/A
N/A	Flare Slope LT (%)	N/A	N/A	Flare Slope RT (%)	N/A
N/A	Flare Traversable LT?	N/A	N/A	Flare Traversable RT?	N/A
N/A	Landing Length (in)	N/A	N/A	DWS Provided?	N/A
N/A	Landing Width (in)	N/A	N/A	DWS Contrast?	N/A
N/A	Landing Slope (%)	N/A	N/A	DWS Length (in)	N/A
N/A	Landing X Slope (%)	N/A	N/A	DWS Full Width?	N/A
N/A	Landing Curb? (Y/N)	N/A	N/A	DWS Offset (in)	N/A
N/A	Shared Landing?	N/A			
N/A	Gutter Ponding?	N/A	N/A	Gutter Slope (%)	N/A
N/A	Gutter Lip Ht (in)	N/A	N/A	Gutter X Slope (%)	N/A
N/A	Painted X Walk1?	No	N/A	Painted X Walk2?	N/A
	X Walk 1 Direction	To W		X Walk 2 Direction	N/A
	X Walk 1 Width (in)	N/A		X Walk 2 Width (in)	N/A
	X Walk 1 Slope (%)	7.1		X Walk 2 Slope (%)	N/A
	X Walk 1 X Slope (%)	4.3		X Walk 2 X Slope (%)	N/A

N/A	Ramp inside XWalk1?	N/A	N/A	Ramp inside XWalk2?	N/A
	Road Slope (%)	4.3		Clear Space?	N/A
	Road X Slope (%)	7.1	N/A	Clear Space to XWalk (in)	N/A
N/A	Any Obstructions?	N/A	N/A	Storm Grate/Utility Hazard?	N/A
	Obstruction Type			Storm Grate/Utility Type	
		N/A			N/A
			Yes	Surface Condition? (G/P)	Good
			No	Curb Slope (%)	8.5

**Remove & Replace Curb Ramp With Two New Directional Ramps or Equivalent.**
