Access Compliance Report

Public Rights-of-Way (Curb Ramps)

Intersection ID: 29950	Main Street: HAMPTON_PLACE_DR	Cross Street: SUTTONVIEW_DR	Location: SE
ADA ID: EE859F6F9246	Ramp Type: PerpDiag	Initial Pass/Fail: Fail	Overall Compliance: No
Severity Score: 10			
Codes/Mitigation Info/Possible Solution		Field Measurements/Component Compliance

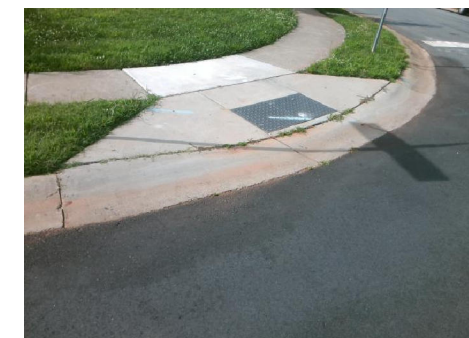
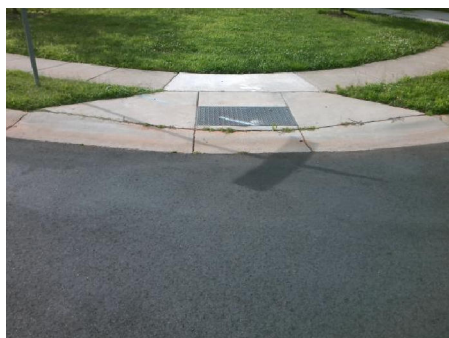
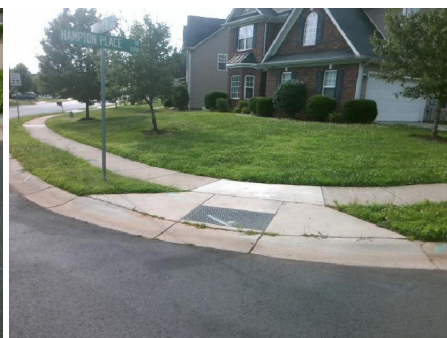
Not Found, R304.5.1, R304.5.3

Compliance	Description	Data	Compliance	Description	Data
N/A	Ramp Length (in)	51.5	Yes	Ramp Slope (%)	6.8
No	Ramp Width (in)	47.0	No	Ramp XSlope (%)	4.7
N/A	Flare Type LT	N/A	N/A	Flare Type RT	N/A
N/A	Flare Slope LT (%)	N/A	N/A	Flare Slope RT (%)	N/A
N/A	Flare Traversable LT?	N/A	N/A	Flare Traversable RT?	N/A
N/A	Landing Length (in)	N/A	N/A	DWS Provided?	N/A
N/A	Landing Width (in)	N/A	N/A	DWS Contrast?	N/A
N/A	Landing Slope (%)	N/A	N/A	DWS Length (in)	N/A
N/A	Landing X Slope (%)	N/A	N/A	DWS Full Width?	N/A
N/A	Landing Curb? (Y/N)	N/A	N/A	DWS Offset (in)	N/A
N/A	Shared Landing?	N/A			
N/A	Gutter Ponding?	N/A	N/A	Gutter Slope (%)	N/A
N/A	Gutter Lip Ht (in)	N/A	N/A	Gutter X Slope (%)	N/A
N/A	Painted X Walk1?	No	N/A	Painted X Walk2?	No
	X Walk 1 Direction	To N		X Walk 2 Direction	To W
N/A	X Walk 1 Width (in)	N/A	N/A	X Walk 2 Width (in)	N/A
	X Walk 1 Slope (%)	4.5		X Walk 2 Slope (%)	2.7
	X Walk 1 X Slope (%)	5.1		X Walk 2 X Slope (%)	0.8

N/A	Ramp inside XWalk1?	N/A	N/A	Ramp inside XWalk2?	N/A
	Road Slope (%)	2.4	N/A	Clear Space?	N/A
	Road X Slope (%)	3.0	N/A	Clear Space to XWalk (in)	N/A
N/A	Any Obstructions?	N/A	N/A	Storm Grate/Utility Hazard?	N/A
	Obstruction Type			Storm Grate/Utility Type	
		N/A			N/A
		Yes		Surface Condition? (G/P)	Good

Possible Solutions:

Remove & Replace Curb Ramp With Two New Directional Ramps or Equivalent.
