Access Compliance Report

Public Rights-of-Way

(Curb Ramps)

Intersection ID: 9381	Main Street: GLENWOOD_DR	Cross Street: PLAINVIEW_RD	Location: S
ADA ID: EE86E48C016F	Ramp Type: Perp	Initial Pass/Fail: Fail	Overall Compliance: No
Codes/Mitigation Info/Possible Solution		Field Measurements/Component Compliance	
Severity Score: 58.75

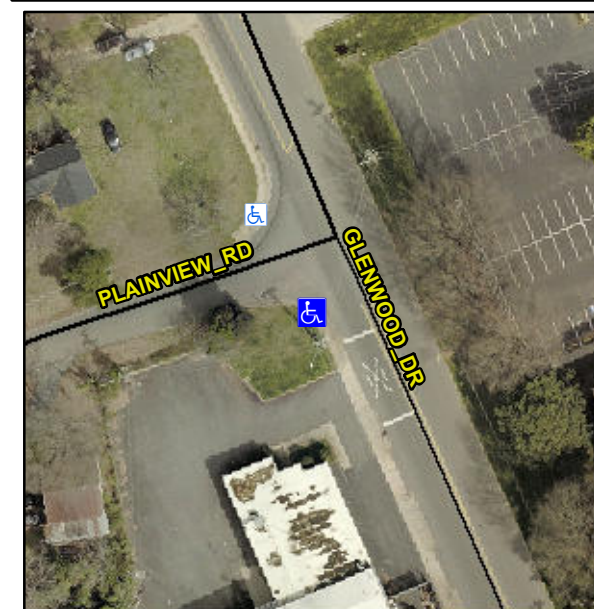
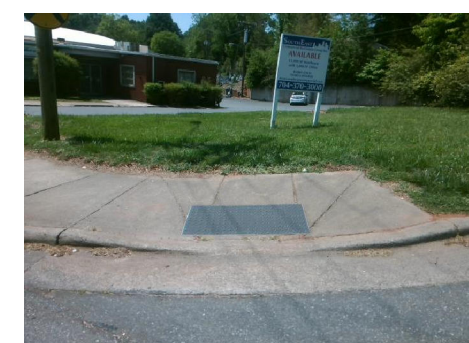
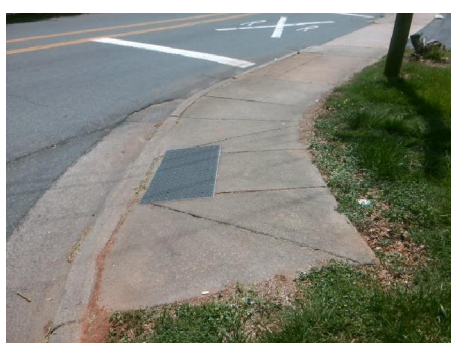
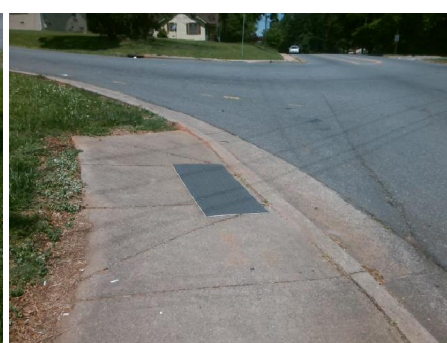
Not Found, R304.5.1, R304.2.2, R304.5.3

Compliance	Description	Data	Compliance	Description	Data
N/A	Ramp Length (in)	65.0	No	Ramp Slope (%)	13.0
No	Ramp Width (in)	36.0	No	Ramp XSlope (%)	10.9
N/A	Flare Type LT	N/A	N/A	Flare Type RT	N/A
N/A	Flare Slope LT (%)	N/A	N/A	Flare Slope RT (%)	N/A
N/A	Flare Traversable LT?	N/A	N/A	Flare Traversable RT?	N/A
N/A	Landing Length (in)	N/A	N/A	DWS Provided?	N/A
N/A	Landing Width (in)	N/A	N/A	DWS Contrast?	N/A
N/A	Landing Slope (%)	N/A	N/A	DWS Length (in)	N/A
N/A	Landing X Slope (%)	N/A	N/A	DWS Full Width?	N/A
N/A	Landing Curb? (Y/N)	N/A	N/A	DWS Offset (in)	N/A
N/A	Shared Landing?	N/A			
N/A	Gutter Ponding?	N/A	N/A	Gutter Slope (%)	N/A
N/A	Gutter Lip Ht (in)	0.5	N/A	Gutter X Slope (%)	N/A
N/A	Painted X Walk1?	No	N/A	Painted X Walk2?	N/A
	X Walk 1 Direction	To N		X Walk 2 Direction	N/A
N/A	X Walk 1 Width (in)	N/A	N/A	X Walk 2 Width (in)	N/A
	X Walk 1 Slope (%)	7.8		X Walk 2 Slope (%)	N/A
	X Walk 1 X Slope (%)	4.1		X Walk 2 X Slope (%)	N/A

N/A	Ramp inside XWalk1?	N/A	N/A	Ramp inside XWalk2?	N/A
	Road Slope (%)	N/A	N/A	Clear Space?	N/A
	Road X Slope (%)	N/A	N/A	Clear Space to XWalk (in)	N/A
N/A	Any Obstructions?	N/A	N/A	Storm Grate/Utility Hazard?	N/A
	Obstruction Type			Storm Grate/Utility Type	
		N/A			N/A
			Yes	Surface Condition? (G/P)	Good

Possible Solutions:

Remove & Replace Entire Ramp.

Total Cost: \$ 1850.00
