# Access Compliance Report

## Public Rights-of-Way

### (Curb Ramps)

Intersection ID: 21411	Main Street: MONROE_RD	Cross Street: SARDIS_RD_NORTH	Location: NE
ADA ID: EE89D08B30CE	Ramp Type: BlendTrans1	Initial Pass/Fail: Pass	Overall Compliance: No
Severity Score: 2.75			
Codes/Mitigation Info/Possible Solution		Field Measurements/Component Compliance

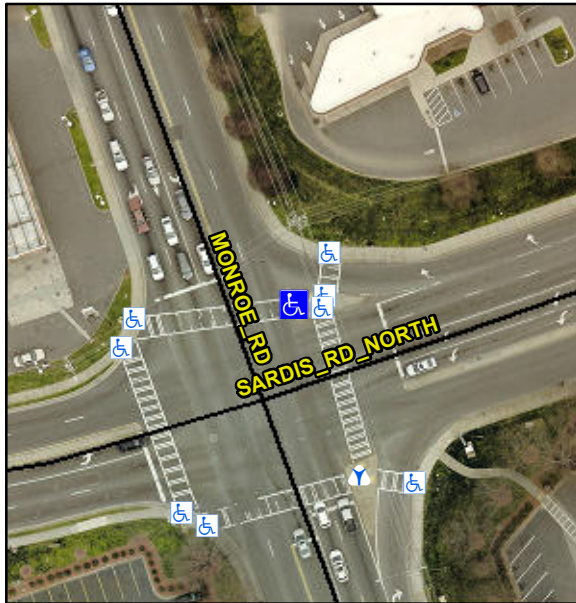
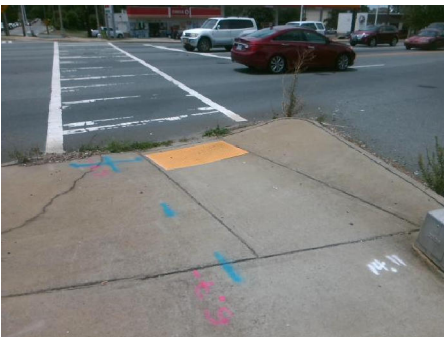
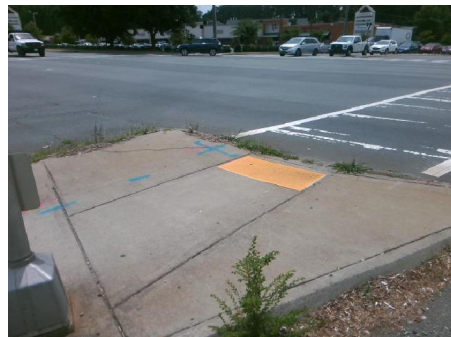
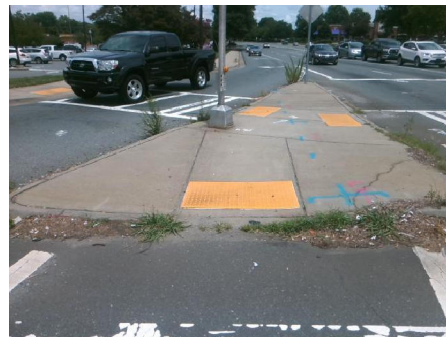
**Remove & Replace Curb Ramp With Two New Directional Ramps or Equivalent. Gutter Ponding Observed.**

**LOCATED ON MEDIAN**

Compliance	Description	Data	Compliance	Description	Data
N/A	Ramp Length (in)	105.0	Yes	BlendTrans Slope (%)	4.0
Yes	Ramp Width (in)	50.0	No	BlendTrans XSlope (%)	3.6
N/A	Flare Type LT	Sloped	N/A	Flare Type RT	Sloped
N/A	Flare Slope LT (%)	6.0	N/A	Flare Slope RT (%)	12.1
N/A	Flare Traversable LT?	No	N/A	Flare Traversable RT?	No
Yes	Landing Length (in)	48.0	Yes	DWS Provided?	Yes
Yes	Landing Width (in)	48.0	Yes	DWS Contrast?	Yes
No	Landing Slope (%)	2.6	Yes	DWS Length (in)	25.5
Yes	Landing X Slope (%)	0.5	No	DWS Full Width?	No
N/A	Landing Curb? (Y/N)	No	No	DWS Offset (in)	6.5
N/A	Shared Landing?	No			
No	Gutter Ponding?	Yes	Yes	Gutter Slope (%)	0.3
Yes	Gutter Lip Ht (in)	0.0	Yes	Gutter X Slope (%)	0.0
N/A	Painted X Walk1?	Yes	N/A	Painted X Walk2?	N/A
	X Walk 1 Direction	To W		X Walk 2 Direction	N/A
	X Walk 1 Width (in)	108.0		X Walk 2 Width (in)	N/A
	X Walk 1 Slope (%)	0.4		X Walk 2 Slope (%)	N/A
	X Walk 1 X Slope (%)	2.0		X Walk 2 X Slope (%)	N/A

Yes	Ramp inside XWalk1?	Yes	N/A	Ramp inside XWalk2?	N/A
	Road Slope (%)	2.0		Clear Space?	Yes
	Road X Slope (%)	0.4	N/A	Clear Space to XWalk (in)	N/A
Yes	Any Obstructions?	No	Yes	Storm Grate/Utility Hazard?	No
	Obstruction Type			Storm Grate/Utility Type	
		N/A			N/A
			Yes	Surface Condition? (G/P)	Good
			N/A	Curb Slope (%)	3.0

Possible Solutions:

**R304.5.3, R304.2.2-Perp, R304.3.2-Para, R305.1.4, R305.2, R302.7**
