Access Compliance Report

Public Rights-of-Way

(Curb Ramps)

Intersection ID: 28462	Main Street: WESTWINDS_CT	Cross Street: LAWING_SCHOOL_RD	Location: S
ADA ID: EE9FF36FFB76	Ramp Type: Directional1	Initial Pass/Fail: Pass	Overall Compliance: No
Codes/Mitigation Info/Possible Solution		Field Measurements/Component Compliance	
Severity Score: 2.5

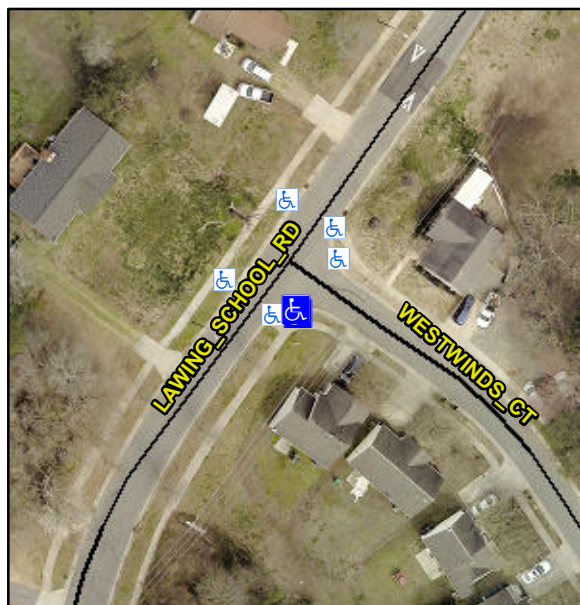
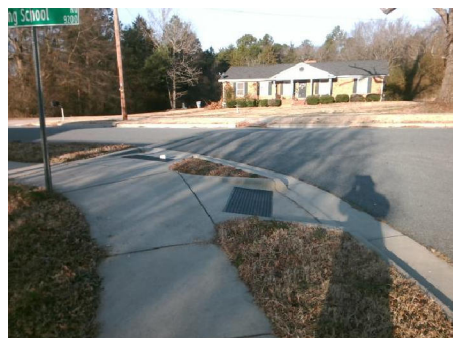
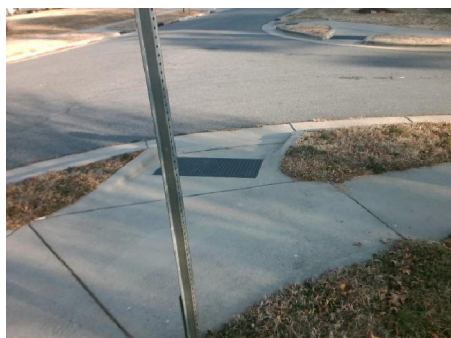
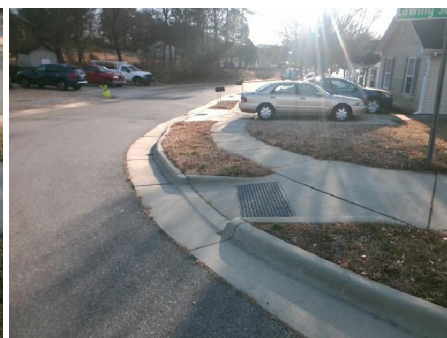
**Not Found, R304.5.3, R305.1.4,
R305.2**

Compliance	Description	Data	Compliance	Description	Data
N/A	Ramp Length (in)	58.0	Yes	Grade Break?	Yes
Yes	Ramp Width (in)	48.0	No	Grade Break Slope (%)	5.7
Yes	Ramp Slope (%)	6.8	Yes	Grade Break XSlope (%)	0.7
Yes	Ramp XSlope (%)	0.5			
Yes	Flare Type LT	N/A	Yes	Flare Type RT	N/A
N/A	Flare Slope LT (%)	N/A	N/A	Flare Slope RT (%)	N/A
N/A	Flare Traversable LT?	No	N/A	Flare Traversable RT?	No
Yes	Landing Length (in)	62.0	Yes	DWS Provided?	Yes
Yes	Landing Width (in)	48.0	Yes	DWS Contrast?	Yes
Yes	Landing Slope (%)	1.2	Yes	DWS Length (in)	24.5
No	Landing X Slope (%)	4.5	No	DWS Full Width?	No
N/A	Landing Curb? (Y/N)	N/A	Yes	DWS Offset LT (in)	25.0
N/A	Shared Landing?	No	No	DWS Offset RT (in)	5.0
Yes	Gutter Ponding?	No	Yes	Gutter Slope (%)	1.3
Yes	Gutter Lip Ht (in)	0.0	No	Gutter X Slope (%)	2.7
N/A	Painted X Walk1?	No		Road Slope (%)	0.4
	X Walk 1 Direction	To N		Road X Slope (%)	3.0
	X Walk 1 Width (in)	N/A		Clear Space?	Yes

X Walk 1 Slope (%)	0.4	N/A	Clear Space to XWalk (in)	N/A
	X Walk 1 X Slope (%)	3.0	Yes	Storm Grate/Utility Hazard?	No
N/A	Ramp inside XWalk1?	N/A		Storm Grate/Utility Type	
Yes	Any Obstructions?	No			N/A
	Obstruction Type		Yes	Surface Condition? (G/P)	Good
			N/A	Curb Slope (%)	22.0

Possible Solutions:

**Remove & Replace Entire Ramp.
Remove & Replace Gutter.**
