Access Compliance Report

Public Rights-of-Way

(Curb Ramps)

Intersection ID: 3828	Main Street: DAVIS_LAKE_PY	Cross Street: OLD_FOX_TL	Location: SW
ADA ID: EEA233C026C0	Ramp Type: Perp	Initial Pass/Fail: Fail	Overall Compliance: No
Severity Score: 12.5			
Codes/Mitigation Info/Possible Solution		Field Measurements/Component Compliance

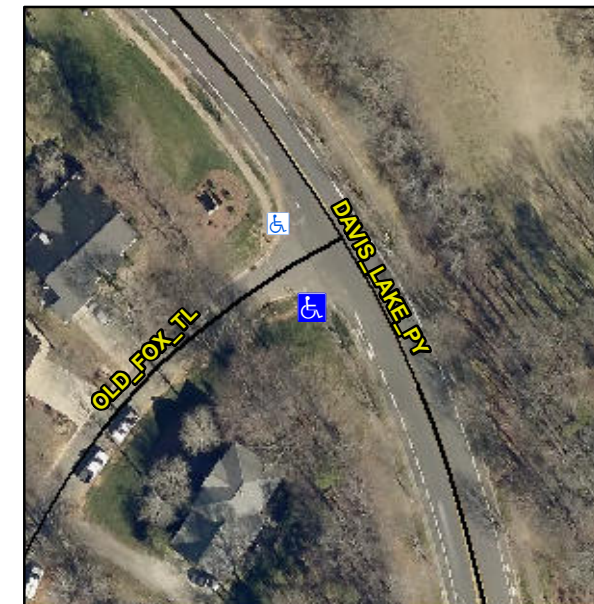
Not Found, R304.2.2

Compliance	Description	Data	Compliance	Description	Data
N/A	Ramp Length (in)	48.0	No	Ramp Slope (%)	8.4
Yes	Ramp Width (in)	64.0	Yes	Ramp XSlope (%)	0.7
N/A	Flare Type LT	N/A	N/A	Flare Type RT	N/A
N/A	Flare Slope LT (%)	N/A	N/A	Flare Slope RT (%)	N/A
N/A	Flare Traversable LT?	N/A	N/A	Flare Traversable RT?	N/A
N/A	Landing Length (in)	N/A	N/A	DWS Provided?	N/A
N/A	Landing Width (in)	N/A	N/A	DWS Contrast?	N/A
N/A	Landing Slope (%)	N/A	N/A	DWS Length (in)	N/A
N/A	Landing X Slope (%)	N/A	N/A	DWS Full Width?	N/A
N/A	Landing Curb? (Y/N)	N/A	N/A	DWS Offset (in)	N/A
N/A	Shared Landing?	N/A			
N/A	Gutter Ponding?	N/A	N/A	Gutter Slope (%)	N/A
N/A	Gutter Lip Ht (in)	N/A	N/A	Gutter X Slope (%)	N/A
N/A	Painted X Walk1?	No	N/A	Painted X Walk2?	N/A
	X Walk 1 Direction	To N		X Walk 2 Direction	N/A
N/A	X Walk 1 Width (in)	N/A	N/A	X Walk 2 Width (in)	N/A
	X Walk 1 Slope (%)	8.8		X Walk 2 Slope (%)	N/A
	X Walk 1 X Slope (%)	0.3		X Walk 2 X Slope (%)	N/A

N/A	Ramp inside XWalk1?	N/A	N/A	Ramp inside XWalk2?	N/A
	Road Slope (%)	N/A	N/A	Clear Space?	N/A
	Road X Slope (%)	N/A	N/A	Clear Space to XWalk (in)	N/A
N/A	Any Obstructions?	N/A	N/A	Storm Grate/Utility Hazard?	N/A
	Obstruction Type			Storm Grate/Utility Type	
		N/A			N/A
			Yes	Surface Condition? (G/P)	Good

Possible Solutions:

Remove & Replace Entire Ramp.
