# Access Compliance Report

## Public Rights-of-Way

### (Curb Ramps)

Intersection ID: 23847	Main Street: ARLANDES_DR	Cross Street: ROZIER_DR	Location: SE
ADA ID: EEA2776E5302	Ramp Type: PerpDiag	Initial Pass/Fail: Fail	Overall Compliance: No
Codes/Mitigation Info/Possible Solution		Field Measurements/Component Compliance	
Severity Score: 31.25

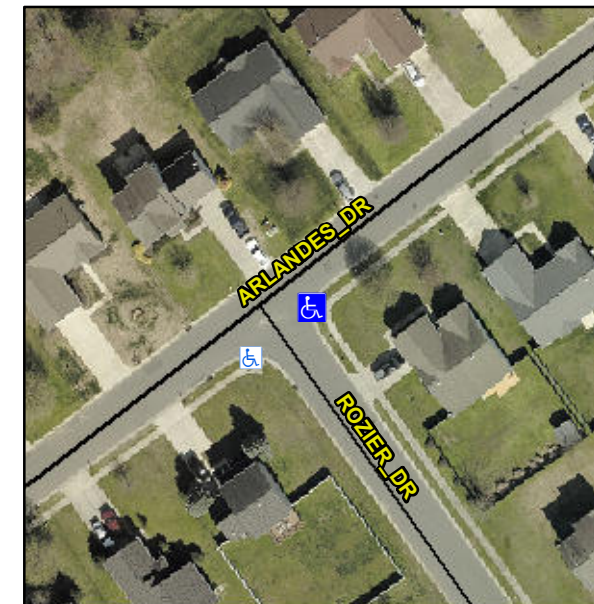
**Not Found, R304.5.1, R304.2.2, R304.5.3**

Compliance	Description	Data	Compliance	Description	Data
N/A	Ramp Length (in)	47.5	No	Ramp Slope (%)	8.4
No	Ramp Width (in)	35.5	No	Ramp XSlope (%)	2.3
N/A	Flare Type LT	N/A	N/A	Flare Type RT	N/A
N/A	Flare Slope LT (%)	N/A	N/A	Flare Slope RT (%)	N/A
N/A	Flare Traversable LT?	N/A	N/A	Flare Traversable RT?	N/A
N/A	Landing Length (in)	N/A	N/A	DWS Provided?	N/A
N/A	Landing Width (in)	N/A	N/A	DWS Contrast?	N/A
N/A	Landing Slope (%)	N/A	N/A	DWS Length (in)	N/A
N/A	Landing X Slope (%)	N/A	N/A	DWS Full Width?	N/A
N/A	Landing Curb? (Y/N)	N/A	N/A	DWS Offset (in)	N/A
N/A	Shared Landing?	N/A			
N/A	Gutter Ponding?	N/A	N/A	Gutter Slope (%)	N/A
N/A	Gutter Lip Ht (in)	N/A	N/A	Gutter X Slope (%)	N/A
N/A	Painted X Walk1?	No	N/A	Painted X Walk2?	No
	X Walk 1 Direction	To NW		X Walk 2 Direction	To SW
N/A	X Walk 1 Width (in)	N/A	N/A	X Walk 2 Width (in)	N/A
	X Walk 1 Slope (%)	0.0		X Walk 2 Slope (%)	1.0
	X Walk 1 X Slope (%)	0.3		X Walk 2 X Slope (%)	1.7

N/A	Ramp inside XWalk1?	N/A	N/A	Ramp inside XWalk2?	N/A
	Road Slope (%)	2.7	N/A	Clear Space?	N/A
	Road X Slope (%)	0.0	N/A	Clear Space to XWalk (in)	N/A
N/A	Any Obstructions?	N/A	N/A	Storm Grate/Utility Hazard?	N/A
	Obstruction Type			Storm Grate/Utility Type	
		N/A			N/A
			Yes	Surface Condition? (G/P)	Good

Possible Solutions:

**Remove & Replace Curb Ramp With Two New Directional Ramps or Equivalent.**
