Access Compliance Report Public Rights-of-Way (Curb Ramps)

Intersection ID: 30550 Main Street: ARBORETUM_SHOPPING_CENTERsDRreet: PROVIDENCE_RD Location: SW **Severity Score:** ADA ID: EEA28B1408FB Ramp Type: PerpDiag Initial Pass/Fail: Fail **Overall Compliance: No** 12.5

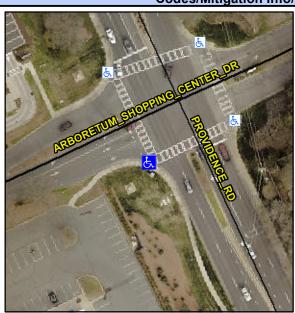
Field Measurements/Component Compliance							
Compliance Description		Data	Comp	liance Description	Data		
N/A	Ramp Length (in)	62.0	No	Ramp Slope (%)	9.6		
Yes	Ramp Width (in)	52.0	Yes	Ramp XSlope (%)	0.2		
N/A	Flare Type LT	N/A	N/A	Flare Type RT	N/A		
N/A	Flare Slope LT (%)	N/A	N/A	Flare Slope RT (%)	N/A		
N/A	Flare Traversable LT?	N/A	N/A	Flare Traversable RT?	N/A		
N/A	Landing Length (in)	N/A	N/A	DWS Provided?	N/A		
N/A	Landing Width (in)	N/A	N/A	DWS Contrast?	N/A		
N/A	Landing Slope (%)	N/A	N/A	DWS Length (in)	N/A		
N/A	Landing X Slope (%)	N/A	N/A	DWS Full Width?	N/A		
N/A	Landing Curb? (Y/N)	N/A	N/A	DWS Offset (in)	N/A		
N/A	Shared Landing?	N/A					
N/A	Gutter Ponding?	N/A	N/A	Gutter Slope (%)	N/A		
N/A	Gutter Lip Ht (in)	N/A	N/A	Gutter X Slope (%)	N/A		
N/A	Painted X Walk1?	Yes	N/A	Painted X Walk2?	Yes		
	X Walk 1 Direction	To NE		X Walk 2 Direction	To NW		
N/A	X Walk 1 Width (in)	103.0	N/A	X Walk 2 Width (in)	94.0

X Walk 1 Slope (%)	0.6		X Walk 2 Slope (%)	2.0		
	X Walk 1 X Slope (%)	0.5		X Walk 2 X Slope (%)	1.8		
N/A	Ramp inside XWalk1?	Yes	N/A	Ramp inside XWalk2?	No		
	Road Slope (%)	2.2	N/A	Clear Space?	N/A		
	Road X Slope (%)	1.2	N/A	Clear Space to XWalk (in)	N/A		
N/A	Any Obstructions?	N/A	N/A	Storm Grate/Utility Hazard?	N/A		
	Obstruction Type			Storm Grate/Utility Type			
		N/A			N/A		
			Yes	Surface Condition? (G/P)	Good		
fichanis Instants	7

Possible Solution				
Possible Solutions:	9			
Remove & Replace Curb Ramp With	ı			
Two New Directional Ramps or	Y			
Equivalent. Restripe Crosswalk.				
	1			
	1			
	1			
Surveyor Notes:	1			
N/A	1			
	1			
	1			
	1			
PROW/ADA:	1			
Not Found, R304.2.2				
	N			
	N
