# Access Compliance Report

## Public Rights-of-Way

Intersection ID: N/A	Main Street: ALLEGIANCE DR	Cross Street: LADY LIBERTY LN	Location: NW
ADA ID: EEA9E4B8E071	Ramp Type: BlendTrans1	Initial Pass/Fail: Fail	Overall Compliance: No
Severity Score: 12.5			
Codes/Mitigation Info/Possible Solution		Field Measurements/Component Compliance

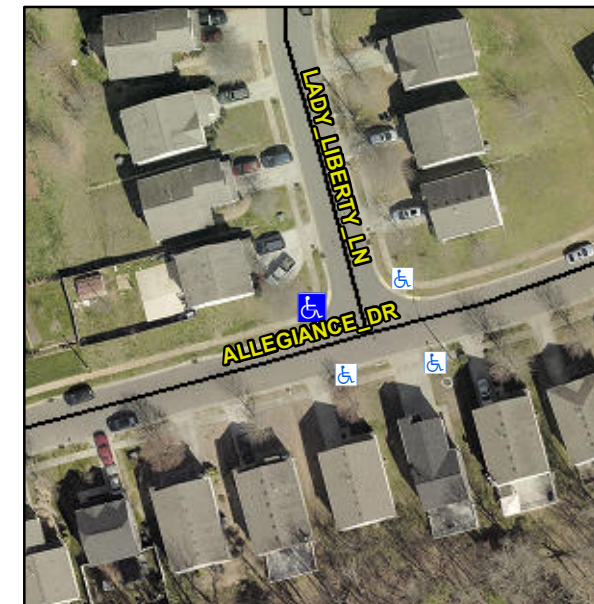
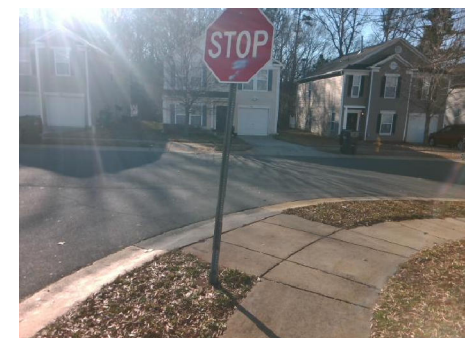
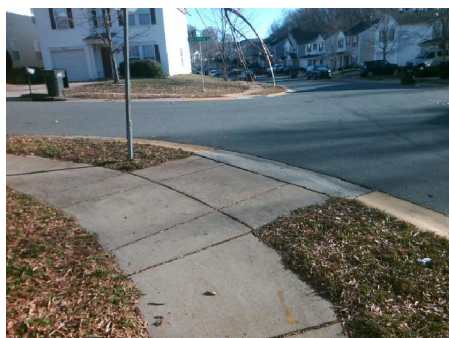
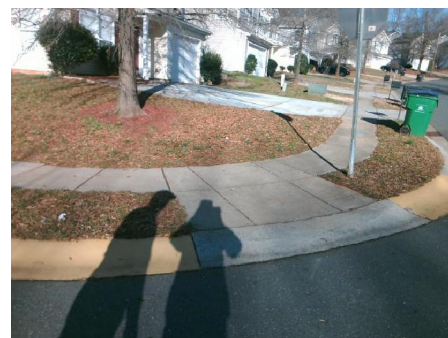
**Not Found, R304.5.3**

Compliance	Description	Data	Compliance	Description	Data
N/A	Ramp Length (in)	49.0	Yes	BlendTrans Slope (%)	4.3
Yes	Ramp Width (in)	48.0	No	BlendTrans XSlope (%)	5.3
N/A	Flare Type LT	N/A	N/A	Flare Type RT	N/A
N/A	Flare Slope LT (%)	N/A	N/A	Flare Slope RT (%)	N/A
N/A	Flare Traversable LT?	No	N/A	Flare Traversable RT?	No
N/A	Landing Length (in)	N/A	N/A	DWS Provided?	N/A
N/A	Landing Width (in)	N/A	N/A	DWS Contrast?	N/A
N/A	Landing Slope (%)	N/A	N/A	DWS Length (in)	N/A
N/A	Landing X Slope (%)	N/A	N/A	DWS Full Width?	N/A
N/A	Landing Curb? (Y/N)	N/A	N/A	DWS Offset (in)	N/A
N/A	Shared Landing?	N/A			
N/A	Gutter Ponding?	N/A	N/A	Gutter Slope (%)	N/A
N/A	Gutter Lip Ht (in)	N/A	N/A	Gutter X Slope (%)	N/A
N/A	Painted X Walk1?	No	N/A	Painted X Walk2?	No
	X Walk 1 Direction	To S		X Walk 2 Direction	To E
	X Walk 1 Width (in)	N/A		X Walk 2 Width (in)	N/A
	X Walk 1 Slope (%)	3.3		X Walk 2 Slope (%)	1.3
	X Walk 1 X Slope (%)	3.5		X Walk 2 X Slope (%)	3.9

N/A	Ramp inside XWalk1?	N/A	N/A	Ramp inside XWalk2?	No
	Road Slope (%)	5.1		Clear Space?	N/A
	Road X Slope (%)	0.3	N/A	Clear Space to XWalk (in)	N/A
N/A	Any Obstructions?	N/A	N/A	Storm Grate/Utility Hazard?	N/A
	Obstruction Type			Storm Grate/Utility Type	
		N/A			N/A
			Yes	Surface Condition? (G/P)	Good
			No	Curb Slope (%)	6.1

**Remove & Replace Curb Ramp With Two New Directional Ramps or Equivalent.**

Total Cost: \$ 3200.00
