# Access Compliance Report

## Public Rights-of-Way

### (Curb Ramps)

Intersection ID: 21320	Main Street: FREDERICK_PL	Cross Street: PARK_RD	Location:	SE
ADA ID: EEB4C5ACECBE	Ramp Type: Perp	Initial Pass/Fail: Fail	Overall Compliance: No	Severity Score: 10
Codes/Mitigation Info/Possible Solution		Field Measurements/Component Compliance

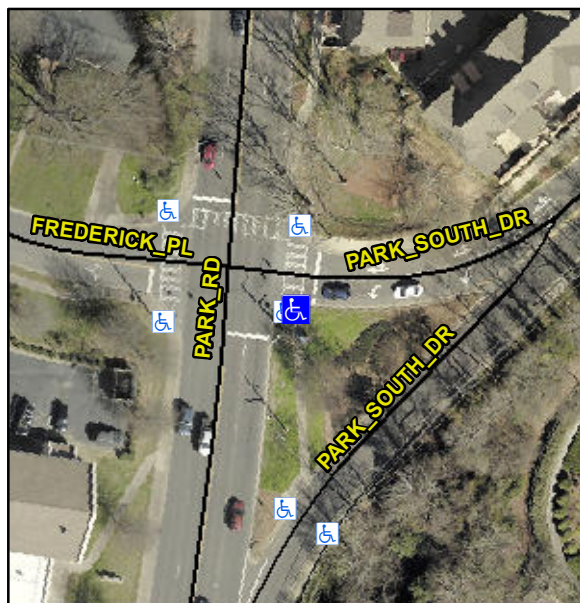
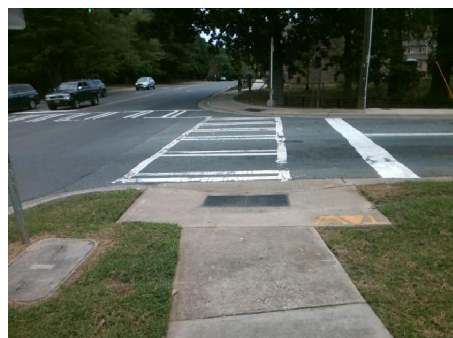
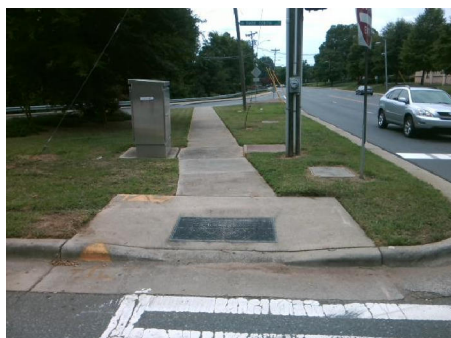
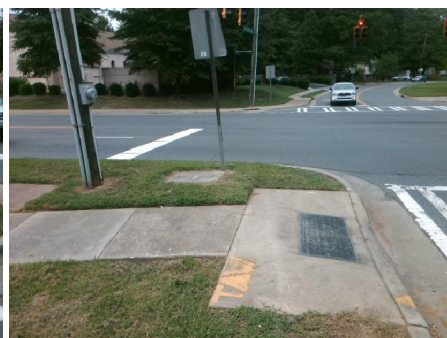
**Not Found, R304.5.1, R304.5.3**

Compliance	Description	Data	Compliance	Description	Data
N/A	Ramp Length (in)	60.0	Yes	Ramp Slope (%)	6.6
No	Ramp Width (in)	45.0	No	Ramp XSlope (%)	2.2
N/A	Flare Type LT	N/A	N/A	Flare Type RT	N/A
N/A	Flare Slope LT (%)	N/A	N/A	Flare Slope RT (%)	N/A
N/A	Flare Traversable LT?	N/A	N/A	Flare Traversable RT?	N/A
N/A	Landing Length (in)	N/A	N/A	DWS Provided?	N/A
N/A	Landing Width (in)	N/A	N/A	DWS Contrast?	N/A
N/A	Landing Slope (%)	N/A	N/A	DWS Length (in)	N/A
N/A	Landing X Slope (%)	N/A	N/A	DWS Full Width?	N/A
N/A	Landing Curb? (Y/N)	N/A	N/A	DWS Offset (in)	N/A
N/A	Shared Landing?	N/A			
N/A	Gutter Ponding?	N/A	N/A	Gutter Slope (%)	N/A
N/A	Gutter Lip Ht (in)	N/A	N/A	Gutter X Slope (%)	N/A
N/A	Painted X Walk1?	Yes	N/A	Painted X Walk2?	N/A
	X Walk 1 Direction	To NE		X Walk 2 Direction	N/A
N/A	X Walk 1 Width (in)	112.0	N/A	X Walk 2 Width (in)	N/A
	X Walk 1 Slope (%)	0.0		X Walk 2 Slope (%)	N/A
	X Walk 1 X Slope (%)	1.2		X Walk 2 X Slope (%)	N/A

N/A	Ramp inside XWalk1?	Yes	N/A	Ramp inside XWalk2?	N/A
	Road Slope (%)	N/A	N/A	Clear Space?	N/A
	Road X Slope (%)	N/A	N/A	Clear Space to XWalk (in)	N/A
N/A	Any Obstructions?	N/A	N/A	Storm Grate/Utility Hazard?	N/A
	Obstruction Type			Storm Grate/Utility Type	
		N/A			N/A
		Yes		Surface Condition? (G/P)	Good

**Remove & Replace Entire Ramp.**

Total Cost: \$ 1850.00
