# Access Compliance Report

## Public Rights-of-Way

### (Curb Ramps)

Intersection ID: 3683	Main Street: BROMPTON_LN	Cross Street: DAVIS_LAKE_PY	Location: SE
ADA ID: EEB72AA1E49E	Ramp Type: Perp	Initial Pass/Fail: Fail	Overall Compliance: No
			Severity Score: 8.75
Codes/Mitigation Info/Possible Solution		Field Measurements/Component Compliance

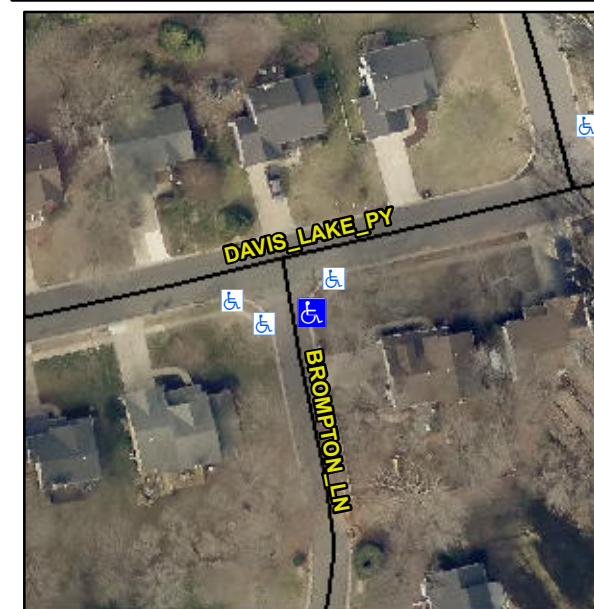
**Not Found, R304.5.1**

Compliance	Description	Data	Compliance	Description	Data
N/A	Ramp Length (in)	52.0	Yes	Ramp Slope (%)	5.6
No	Ramp Width (in)	46.0	Yes	Ramp XSlope (%)	0.7
N/A	Flare Type LT	N/A	N/A	Flare Type RT	N/A
N/A	Flare Slope LT (%)	N/A	N/A	Flare Slope RT (%)	N/A
N/A	Flare Traversable LT?	N/A	N/A	Flare Traversable RT?	N/A
N/A	Landing Length (in)	N/A	N/A	DWS Provided?	N/A
N/A	Landing Width (in)	N/A	N/A	DWS Contrast?	N/A
N/A	Landing Slope (%)	N/A	N/A	DWS Length (in)	N/A
N/A	Landing X Slope (%)	N/A	N/A	DWS Full Width?	N/A
N/A	Landing Curb? (Y/N)	N/A	N/A	DWS Offset (in)	N/A
N/A	Shared Landing?	N/A			
N/A	Gutter Ponding?	N/A	N/A	Gutter Slope (%)	N/A
N/A	Gutter Lip Ht (in)	N/A	N/A	Gutter X Slope (%)	N/A
N/A	Painted X Walk1?	No	N/A	Painted X Walk2?	N/A
	X Walk 1 Direction	To W		X Walk 2 Direction	N/A
N/A	X Walk 1 Width (in)	N/A	N/A	X Walk 2 Width (in)	N/A
	X Walk 1 Slope (%)	2.6		X Walk 2 Slope (%)	N/A
	X Walk 1 X Slope (%)	1.0		X Walk 2 X Slope (%)	N/A

N/A	Ramp inside XWalk1?	N/A	N/A	Ramp inside XWalk2?	N/A
	Road Slope (%)	N/A	N/A	Clear Space?	N/A
	Road X Slope (%)	N/A	N/A	Clear Space to XWalk (in)	N/A
N/A	Any Obstructions?	N/A	N/A	Storm Grate/Utility Hazard?	N/A
	Obstruction Type			Storm Grate/Utility Type	
		N/A			N/A
			Yes	Surface Condition? (G/P)	Good

**Remove & Replace Entire Ramp.**

Total Cost: \$ 1850.00
