Access Compliance Report

Public Rights-of-Way

(Curb Ramps)

Intersection ID: 15542	Main Street: CLANTON_RD	Cross Street: N/A	Location: NE
ADA ID: EEBA55A76732	Ramp Type: Perp	Initial Pass/Fail: Fail	Overall Compliance: No
Severity Score: 21.25			
Codes/Mitigation Info/Possible Solution		Field Measurements/Component Compliance

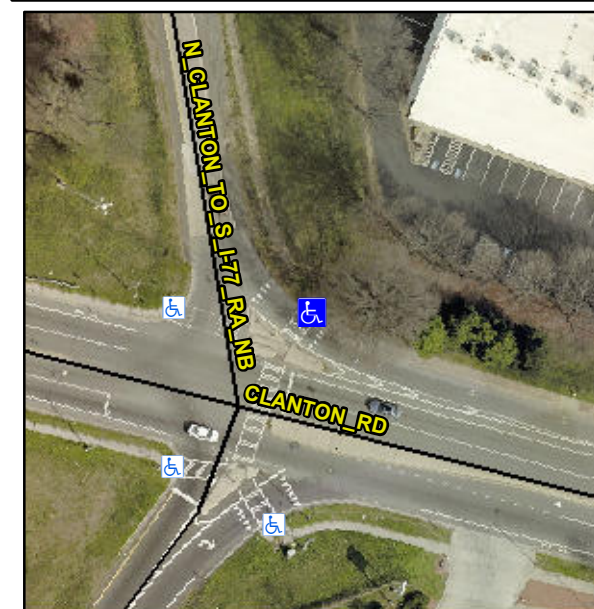
R304.5.1, R304.2.2

Compliance	Description	Data	Compliance	Description	Data
N/A	Ramp Length (in)	72.0	No	Ramp Slope (%)	9.4
No	Ramp Width (in)	47.0	Yes	Ramp XSlope (%)	1.7
N/A	Flare Type LT	N/A	N/A	Flare Type RT	N/A
N/A	Flare Slope LT (%)	N/A	N/A	Flare Slope RT (%)	N/A
N/A	Flare Traversable LT?	N/A	N/A	Flare Traversable RT?	N/A
N/A	Landing Length (in)	N/A	N/A	DWS Provided?	N/A
N/A	Landing Width (in)	N/A	N/A	DWS Contrast?	N/A
N/A	Landing Slope (%)	N/A	N/A	DWS Length (in)	N/A
N/A	Landing X Slope (%)	N/A	N/A	DWS Full Width?	N/A
N/A	Landing Curb? (Y/N)	N/A	N/A	DWS Offset (in)	N/A
N/A	Shared Landing?	N/A			
N/A	Gutter Ponding?	N/A	N/A	Gutter Slope (%)	N/A
N/A	Gutter Lip Ht (in)	N/A	N/A	Gutter X Slope (%)	N/A
N/A	Painted X Walk1?	Yes	N/A	Painted X Walk2?	N/A
	X Walk 1 Direction	To SW		X Walk 2 Direction	N/A
N/A	X Walk 1 Width (in)	111.0	N/A	X Walk 2 Width (in)	N/A
	X Walk 1 Slope (%)	3.9		X Walk 2 Slope (%)	N/A
	X Walk 1 X Slope (%)	2.0		X Walk 2 X Slope (%)	N/A

Remove & Replace Entire Ramp.
