Access Compliance Report

Public Rights-of-Way

(Curb Ramps)

Intersection ID: 15548	Main Street: HEMLOCK_ST	Cross Street: SCOTT_AV	Location: W
ADA ID: EEBC0E5A1FBC	Ramp Type: Directional1	Initial Pass/Fail: Fail	Overall Compliance: No
		Severity Score: 10

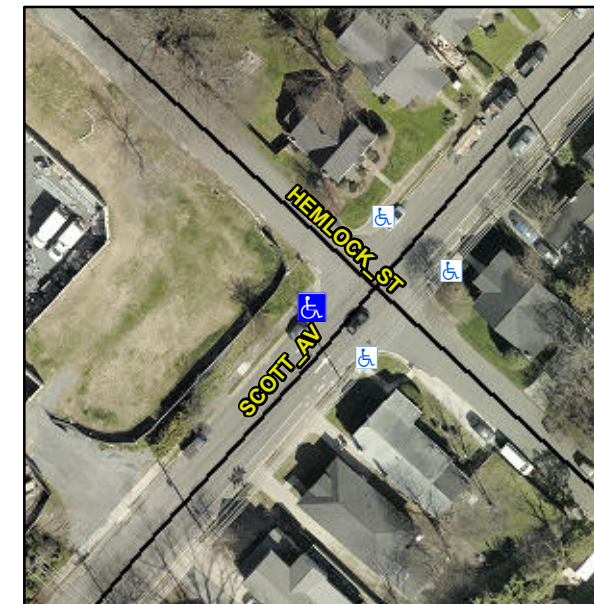
R304.5.1, R304.5.3

Compliance	Description	Data	Compliance	Description	Data
N/A	Ramp Length (in)	36.0	N/A	Grade Break?	N/A
No	Ramp Width (in)	38.0	N/A	Grade Break Slope (%)	0.0
Yes	Ramp Slope (%)	4.0	N/A	Grade Break XSlope (%)	0.0
No	Ramp XSlope (%)	2.3			
N/A	Flare Type LT	N/A	N/A	Flare Type RT	N/A
N/A	Flare Slope LT (%)	N/A	N/A	Flare Slope RT (%)	0.0
N/A	Flare Traversable LT?	N/A	N/A	Flare Traversable RT?	N/A
N/A	Landing Length (in)	0.0	N/A	DWS Provided?	N/A
N/A	Landing Width (in)	0.0	N/A	DWS Contrast?	N/A
N/A	Landing Slope (%)	0.0	N/A	DWS Length (in)	N/A
N/A	Landing X Slope (%)	0.0	N/A	DWS Full Width?	N/A
N/A	Landing Curb? (Y/N)	N/A	N/A	DWS Offset LT (in)	N/A
N/A	Shared Landing?	N/A	N/A	DWS Offset RT (in)	N/A
N/A	Gutter Ponding?	0.0	N/A	Gutter Slope (%)	N/A
N/A	Gutter Lip Ht (in)	0.0	N/A	Gutter X Slope (%)	N/A
N/A	Painted X Walk1?	No		Road Slope (%)	5.3
	X Walk 1 Direction	To NE		Road X Slope (%)	5.9
	X Walk 1 Width (in)	N/A		Clear Space?	N/A

X Walk 1 Slope (%)	5.3	N/A	Clear Space to XWalk (in)	N/A
	X Walk 1 X Slope (%)	5.9	N/A	Storm Grate/Utility Hazard?	N/A
N/A	Ramp inside XWalk1?	N/A		Storm Grate/Utility Type	
N/A	Any Obstructions?	N/A			N/A
	Obstruction Type		Yes	Surface Condition? (G/P)	Good
			N/A	Curb Slope (%)	9.6

Remove & Replace Entire Ramp.
