# Access Compliance Report

## Public Rights-of-Way

### (Curb Ramps)

| Intersection ID: 16097 | Main Street: ROSEHALL_DR | Cross Street: ROSEMEDE_DR | Location: | N |

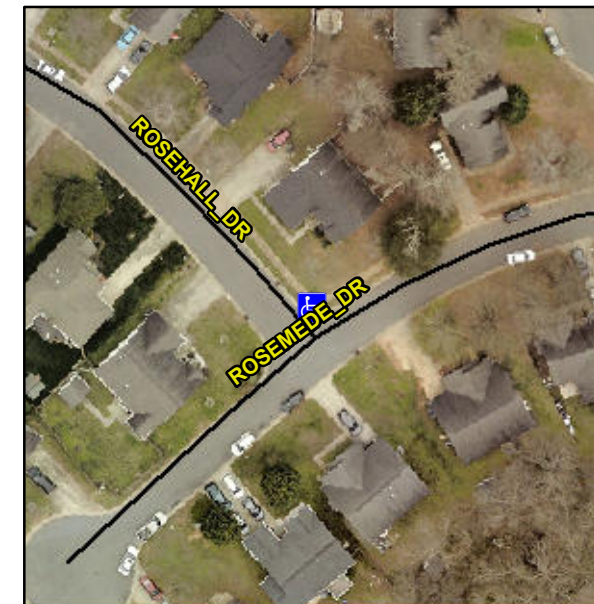
| ADA ID: EEBC0F5D8254 | Ramp Type: PerpDiag | Initial Pass/Fail: Fail | Overall Compliance: No | Severity Score: 10 |

**Not Found, R304.5.1, R304.5.3**

| Compliance | Description | Data | Compliance | Description | Data |
|---|---|---|---|---|---|
| No | Ramp Width (in) | 47.0 | No | Ramp XSlope (%) | 3.3 |

**Remove & Replace Curb Ramp With Two New Directional Ramps or Equivalent.**

Total Cost: \$ 3200.00
