Access Compliance Report Public Rights-of-Way (Curb Ramps)

| Intersection ID: 47880 | Main Street: LAKEDELL_DR | | | Cross Street: PLAZA_MEADOW_DR | | | | | Location: | NW |
| ADA ID: EECA3230D210 | | Ramp Type: Perp | | | Initial Pass/Fail: Fail Overall Complianc | | | nco: N | | 10 |

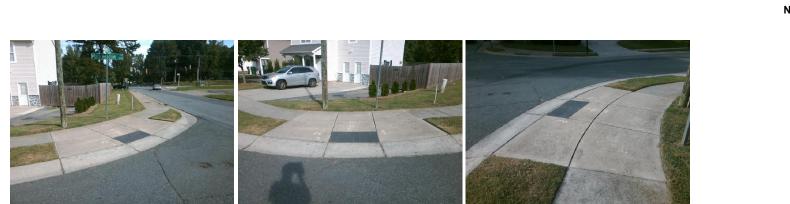
| Intersection ID: 47880 | Main Street: LAKEDELL_DR | | | Cross Street: PLAZA_MEADOW_DR | | | | | Location: | NW |
|--|---|---|---|---|---|---|---|---|---|---|
| E | 6 | Remove & Repla | ce Entire Ramp. | | N/A | Ramp Length (in) | 47.5 | Yes | Ramp Slope (%) | 6.3 |
| Nat States and the last | | | | | No | Ramp Width (in) | 47.0 | No | Ramp XSlope (%) | 4.5 |
| here is the | and the second | Not Found, R304.5.1, R304.5.3 | | | N/A | Gutter Lip Ht (in) | 1.0 | N/A | Gutter X Slope (%) | N/A |
| | | | | | | | | Yes | Surface Condition? (G/P) | Good |

| Intersection ID: 47880 | Main Street: LAKEDELL_DR | | | Cross Street: PLAZA_MEADOW_DR | | | | | Location: | NW |
|--|---|---|---|---|---|---|---|---|---|---|
| | | Total Cost: | \$ 1 | 850.00 | | Obstruction Type | | | Storm Grate/Utility Type | |
