Access Compliance Report

Public Rights-of-Way

(Curb Ramps)

Intersection ID: 14007	Main Street: BEECH_NUT_RD	Cross Street: COWLES_RD	Location:	E
ADA ID: EECEDB57C49A	Ramp Type: PerpDiag	Initial Pass/Fail: Fail	Overall Compliance: No	Severity Score: 25
Codes/Mitigation Info/Possible Solution		Field Measurements/Component Compliance

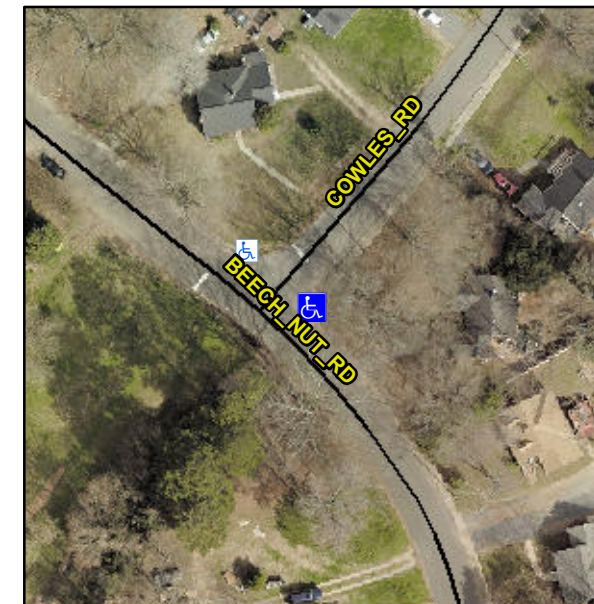
Compliance	Description	Data	Compliance	Description	Data
N/A	Ramp Length (in)	52.0	No	Ramp Slope (%)	12.2
Yes	Ramp Width (in)	48.0	Yes	Ramp XSlope (%)	0.7
N/A	Flare Type LT	N/A	N/A	Flare Type RT	N/A
N/A	Flare Slope LT (%)	N/A	N/A	Flare Slope RT (%)	N/A
N/A	Flare Traversable LT?	N/A	N/A	Flare Traversable RT?	N/A
N/A	Landing Length (in)	N/A	N/A	DWS Provided?	N/A
N/A	Landing Width (in)	N/A	N/A	DWS Contrast?	N/A
N/A	Landing Slope (%)	N/A	N/A	DWS Length (in)	N/A
N/A	Landing X Slope (%)	N/A	N/A	DWS Full Width?	N/A
N/A	Landing Curb? (Y/N)	N/A	N/A	DWS Offset (in)	N/A
N/A	Shared Landing?	N/A			
N/A	Gutter Ponding?	N/A	N/A	Gutter Slope (%)	N/A
N/A	Gutter Lip Ht (in)	N/A	N/A	Gutter X Slope (%)	N/A
N/A	Painted X Walk1?	No	N/A	Painted X Walk2?	No
	X Walk 1 Direction	To NW		X Walk 2 Direction	To SW
N/A	X Walk 1 Width (in)	N/A	N/A	X Walk 2 Width (in)	N/A
	X Walk 1 Slope (%)	1.8		X Walk 2 Slope (%)	2.3
	X Walk 1 X Slope (%)	1.1		X Walk 2 X Slope (%)	0.2

N/A	Ramp inside XWalk1?	N/A	N/A	Ramp inside XWalk2?	N/A
	Road Slope (%)	0.4	N/A	Clear Space?	N/A
	Road X Slope (%)	2.8	N/A	Clear Space to XWalk (in)	N/A
N/A	Any Obstructions?	N/A	N/A	Storm Grate/Utility Hazard?	N/A
	Obstruction Type			Storm Grate/Utility Type	
		N/A			N/A
			Yes	Surface Condition? (G/P)	Good

Possible Solutions:

Remove & Replace Curb Ramp With Two New Directional Ramps or Equivalent.
