# Access Compliance Report

## Public Rights-of-Way

### (Curb Ramps)

Intersection ID: 9514	Main Street: TERRA_COTTA_DR	Cross Street: MOODY_RD	Location: SE
ADA ID: EED1E5FF7E5A	Ramp Type: Perp	Initial Pass/Fail: Fail	Overall Compliance: No
Severity Score: 37.5			
Codes/Mitigation Info/Possible Solution		Field Measurements/Component Compliance

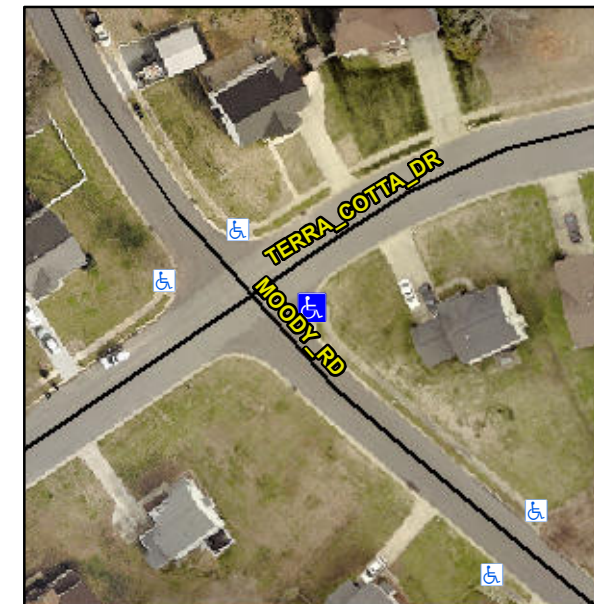
**Not Found, R304.2.2, R304.5.3**

Compliance	Description	Data	Compliance	Description	Data
N/A	Ramp Length (in)	45.0	No	Ramp Slope (%)	8.6
Yes	Ramp Width (in)	48.0	No	Ramp XSlope (%)	7.9
N/A	Flare Type LT	N/A	N/A	Flare Type RT	N/A
N/A	Flare Slope LT (%)	N/A	N/A	Flare Slope RT (%)	N/A
N/A	Flare Traversable LT?	N/A	N/A	Flare Traversable RT?	N/A
N/A	Landing Length (in)	N/A	N/A	DWS Provided?	N/A
N/A	Landing Width (in)	N/A	N/A	DWS Contrast?	N/A
N/A	Landing Slope (%)	N/A	N/A	DWS Length (in)	N/A
N/A	Landing X Slope (%)	N/A	N/A	DWS Full Width?	N/A
N/A	Landing Curb? (Y/N)	N/A	N/A	DWS Offset (in)	N/A
N/A	Shared Landing?	N/A			
N/A	Gutter Ponding?	N/A	N/A	Gutter Slope (%)	N/A
N/A	Gutter Lip Ht (in)	N/A	N/A	Gutter X Slope (%)	N/A
N/A	Painted X Walk1?	No	N/A	Painted X Walk2?	N/A
	X Walk 1 Direction	To NW		X Walk 2 Direction	N/A
N/A	X Walk 1 Width (in)	N/A	N/A	X Walk 2 Width (in)	N/A
	X Walk 1 Slope (%)	10.1		X Walk 2 Slope (%)	N/A
	X Walk 1 X Slope (%)	0.6		X Walk 2 X Slope (%)	N/A

N/A	Ramp inside XWalk1?	N/A	N/A	Ramp inside XWalk2?	N/A
	Road Slope (%)	N/A	N/A	Clear Space?	N/A
	Road X Slope (%)	N/A	N/A	Clear Space to XWalk (in)	N/A
N/A	Any Obstructions?	N/A	N/A	Storm Grate/Utility Hazard?	N/A
	Obstruction Type			Storm Grate/Utility Type	
		N/A			N/A
			Yes	Surface Condition? (G/P)	Good

Possible Solutions:

**Remove & Replace Entire Ramp.**
