# Access Compliance Report

## Public Rights-of-Way

### (Curb Ramps)

| Intersection ID: 9690 | Main Street: NORWOOD_DR | Cross Street: PARKWAY_AV | Location: | E |

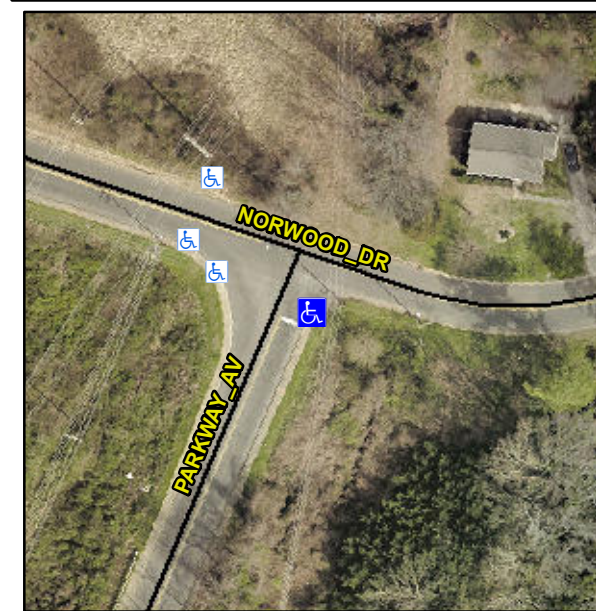
| ADA ID: EEE71E8E836F | Ramp Type: Perp | Initial Pass/Fail: Fail | Overall Compliance: No | Severity Score: 10 |

**Not Found, R304.5.1, R304.5.3**

| Compliance | Description | Data | Compliance | Description | Data |
|---|---|---|---|---|---|
| No | Ramp Width (in) | 36.0 | No | Ramp XSlope (%) | 2.3 |

**Remove & Replace Entire Ramp.**
