Access Compliance Report

Public Rights-of-Way

(Curb Ramps)

Intersection ID: 50594	Main Street: BEAR_GRASS_LN	Cross Street: GRAY_WILLOW_RD	Location:	N
ADA ID: EEEB376384DE	Ramp Type: Perp	Initial Pass/Fail: Fail	Overall Compliance: No	Severity Score: 10

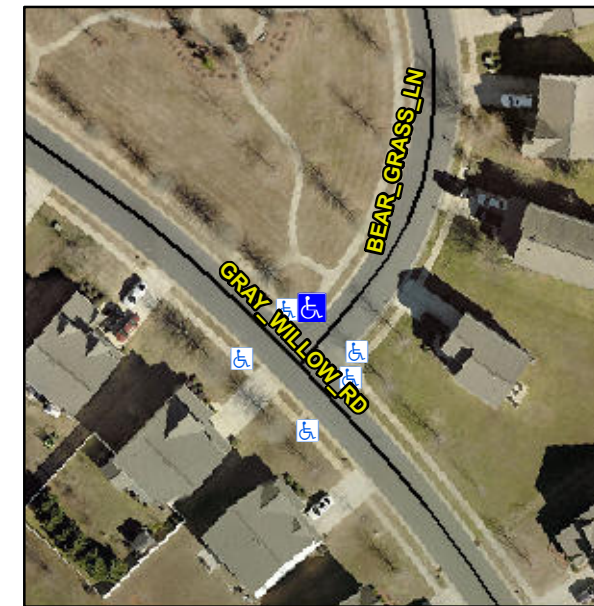
Not Found, R304.5.1, R304.5.3

Compliance	Description	Data	Compliance	Description	Data
N/A	Ramp Length (in)	51.5	Yes	Ramp Slope (%)	7.3
No	Ramp Width (in)	46.0	No	Ramp XSlope (%)	2.9
N/A	Flare Type LT	N/A	N/A	Flare Type RT	N/A
N/A	Flare Slope LT (%)	N/A	N/A	Flare Slope RT (%)	N/A
N/A	Flare Traversable LT?	N/A	N/A	Flare Traversable RT?	N/A
N/A	Landing Length (in)	N/A	N/A	DWS Provided?	N/A
N/A	Landing Width (in)	N/A	N/A	DWS Contrast?	N/A
N/A	Landing Slope (%)	N/A	N/A	DWS Length (in)	N/A
N/A	Landing X Slope (%)	N/A	N/A	DWS Full Width?	N/A
N/A	Landing Curb? (Y/N)	N/A	N/A	DWS Offset (in)	N/A
N/A	Shared Landing?	N/A			
N/A	Gutter Ponding?	N/A	N/A	Gutter Slope (%)	N/A
N/A	Gutter Lip Ht (in)	N/A	N/A	Gutter X Slope (%)	N/A
N/A	Painted X Walk1?	No	N/A	Painted X Walk2?	N/A
	X Walk 1 Direction	To SE		X Walk 2 Direction	N/A
N/A	X Walk 1 Width (in)	N/A	N/A	X Walk 2 Width (in)	N/A
	X Walk 1 Slope (%)	0.4		X Walk 2 Slope (%)	N/A
	X Walk 1 X Slope (%)	2.8		X Walk 2 X Slope (%)	N/A

N/A	Ramp inside XWalk1?	N/A	N/A	Ramp inside XWalk2?	N/A
	Road Slope (%)	N/A	N/A	Clear Space?	N/A
	Road X Slope (%)	N/A	N/A	Clear Space to XWalk (in)	N/A
N/A	Any Obstructions?	N/A	N/A	Storm Grate/Utility Hazard?	N/A
	Obstruction Type			Storm Grate/Utility Type	
		N/A			N/A
			Yes	Surface Condition? (G/P)	Good

Remove & Replace Entire Ramp.
