Access Compliance Report

Public Rights-of-Way

(Curb Ramps)

Intersection ID: 25795	Main Street: PINEVILLE-MATTHEWS_RD	Cross Street: CARY_RIDGE_DR	Location: SE
ADA ID: EEEB6A306135	Ramp Type: Perp	Initial Pass/Fail: Fail	Overall Compliance: No
Severity Score: 21.25			
Codes/Mitigation Info/Possible Solution		Field Measurements/Component Compliance

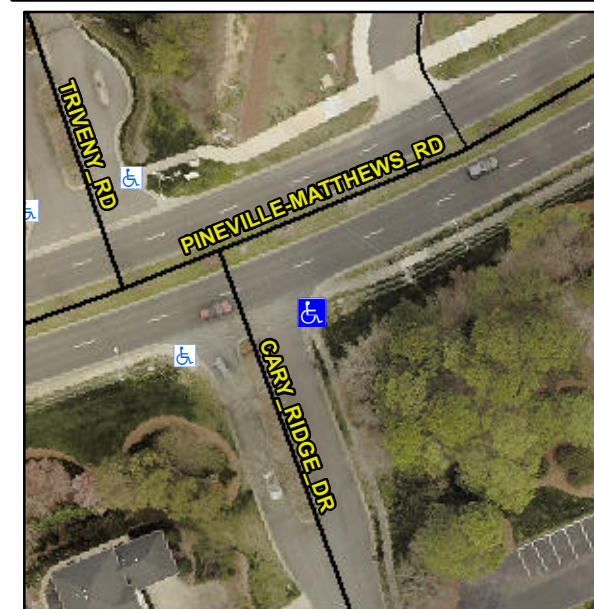
Not Found, R304.5.1, R304.2.2

Compliance	Description	Data	Compliance	Description	Data
N/A	Ramp Length (in)	61.0	No	Ramp Slope (%)	9.4
No	Ramp Width (in)	39.0	Yes	Ramp XSlope (%)	1.8
N/A	Flare Type LT	N/A	N/A	Flare Type RT	N/A
N/A	Flare Slope LT (%)	N/A	N/A	Flare Slope RT (%)	N/A
N/A	Flare Traversable LT?	N/A	N/A	Flare Traversable RT?	N/A
N/A	Landing Length (in)	N/A	N/A	DWS Provided?	N/A
N/A	Landing Width (in)	N/A	N/A	DWS Contrast?	N/A
N/A	Landing Slope (%)	N/A	N/A	DWS Length (in)	N/A
N/A	Landing X Slope (%)	N/A	N/A	DWS Full Width?	N/A
N/A	Landing Curb? (Y/N)	N/A	N/A	DWS Offset (in)	N/A
N/A	Shared Landing?	N/A			
N/A	Gutter Ponding?	N/A	N/A	Gutter Slope (%)	N/A
N/A	Gutter Lip Ht (in)	N/A	N/A	Gutter X Slope (%)	N/A
N/A	Painted X Walk1?	No	N/A	Painted X Walk2?	N/A
	X Walk 1 Direction	To W		X Walk 2 Direction	N/A
N/A	X Walk 1 Width (in)	N/A	N/A	X Walk 2 Width (in)	N/A
	X Walk 1 Slope (%)	0.1		X Walk 2 Slope (%)	N/A
	X Walk 1 X Slope (%)	4.3		X Walk 2 X Slope (%)	N/A

N/A	Ramp inside XWalk1?	N/A	N/A	Ramp inside XWalk2?	N/A
	Road Slope (%)	N/A	N/A	Clear Space?	N/A
	Road X Slope (%)	N/A	N/A	Clear Space to XWalk (in)	N/A
N/A	Any Obstructions?	N/A	N/A	Storm Grate/Utility Hazard?	N/A
	Obstruction Type			Storm Grate/Utility Type	
		N/A			N/A
		Yes		Surface Condition? (G/P)	Good

Possible Solutions:

Remove & Replace Entire Ramp.
