Access Compliance Report

Public Rights-of-Way

(Curb Ramps)

Intersection ID: 52996	Main Street: TIMBERBROOK_DR	Cross Street: VICTORIA_BROOK_LN	Location: NW
ADA ID: EEF4BB1D1215	Ramp Type: PerpDiag	Initial Pass/Fail: Fail	Overall Compliance: No
Severity Score: 13.75			
Codes/Mitigation Info/Possible Solution		Field Measurements/Component Compliance

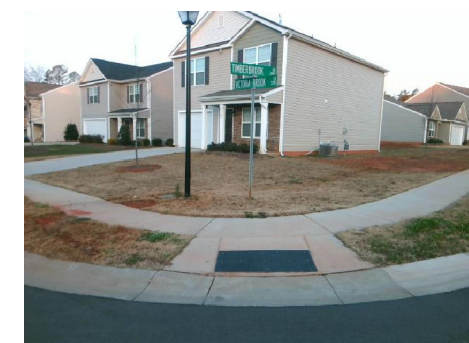
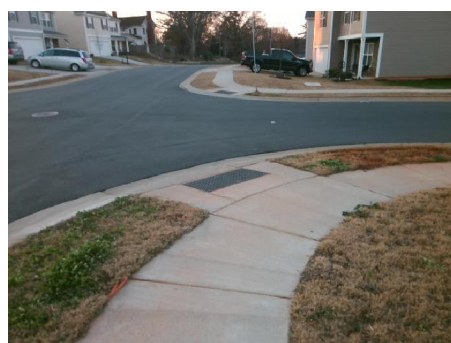
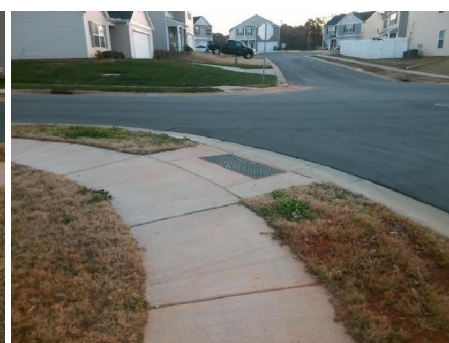
Not Found, R304.2.2, R304.5.3

Compliance	Description	Data	Compliance	Description	Data
N/A	Ramp Length (in)	48.5	No	Ramp Slope (%)	9.0
Yes	Ramp Width (in)	48.0	No	Ramp XSlope (%)	3.7
N/A	Flare Type LT	N/A	N/A	Flare Type RT	N/A
N/A	Flare Slope LT (%)	N/A	N/A	Flare Slope RT (%)	N/A
N/A	Flare Traversable LT?	N/A	N/A	Flare Traversable RT?	N/A
N/A	Landing Length (in)	N/A	N/A	DWS Provided?	N/A
N/A	Landing Width (in)	N/A	N/A	DWS Contrast?	N/A
N/A	Landing Slope (%)	N/A	N/A	DWS Length (in)	N/A
N/A	Landing X Slope (%)	N/A	N/A	DWS Full Width?	N/A
N/A	Landing Curb? (Y/N)	N/A	N/A	DWS Offset (in)	N/A
N/A	Shared Landing?	N/A			
N/A	Gutter Ponding?	N/A	N/A	Gutter Slope (%)	N/A
N/A	Gutter Lip Ht (in)	N/A	N/A	Gutter X Slope (%)	N/A
N/A	Painted X Walk1?	No	N/A	Painted X Walk2?	No
	X Walk 1 Direction	To S		X Walk 2 Direction	To E
N/A	X Walk 1 Width (in)	N/A	N/A	X Walk 2 Width (in)	N/A
	X Walk 1 Slope (%)	0.5		X Walk 2 Slope (%)	4.5
	X Walk 1 X Slope (%)	4.0		X Walk 2 X Slope (%)	0.3

N/A	Ramp inside XWalk1?	N/A	N/A	Ramp inside XWalk2?	N/A
	Road Slope (%)	3.0	N/A	Clear Space?	N/A
	Road X Slope (%)	3.2	N/A	Clear Space to XWalk (in)	N/A
N/A	Any Obstructions?	N/A	N/A	Storm Grate/Utility Hazard?	N/A
	Obstruction Type			Storm Grate/Utility Type	
		N/A			N/A
		Yes		Surface Condition? (G/P)	Good

Remove & Replace Curb Ramp With Two New Directional Ramps or Equivalent.
