Access Compliance Report

Public Rights-of-Way

(Curb Ramps)

Intersection ID: N/A	Main Street: TERRACE_DR	Cross Street: BOYCE_RD	Location: NW
ADA ID: EEFDB4A7FEA3	Ramp Type: Directional1	Initial Pass/Fail: Fail	Overall Compliance: No
Severity Score: 58.75			
Codes/Mitigation Info/Possible Solution		Field Measurements/Component Compliance

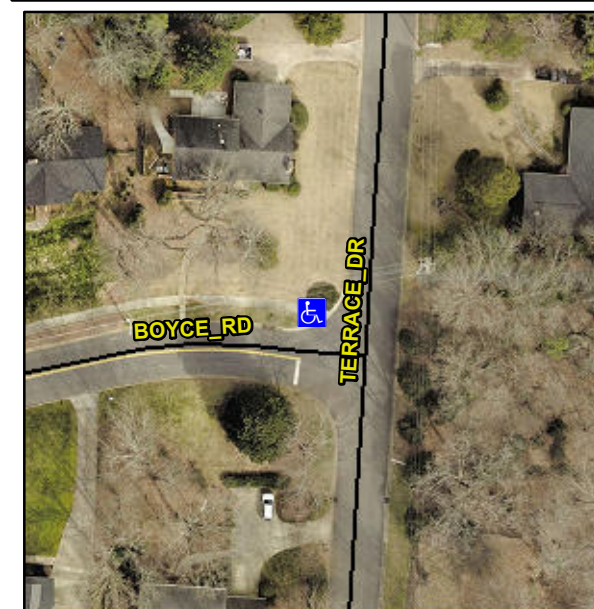
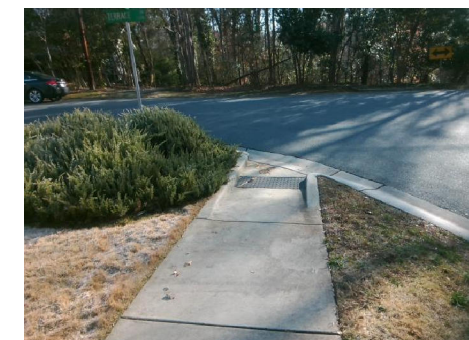
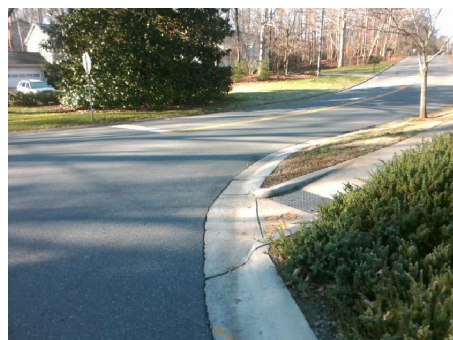
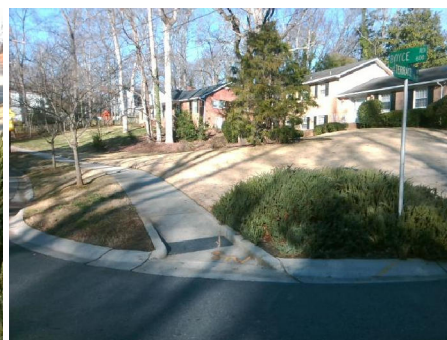
Compliance	Description	Data	Compliance	Description	Data
N/A	Ramp Length (in)	86.0	N/A	Grade Break?	N/A
No	Ramp Width (in)	46.0	N/A	Grade Break Slope (%)	0.0
No	Ramp Slope (%)	12.4	N/A	Grade Break XSlope (%)	0.0
No	Ramp XSlope (%)	7.0			
N/A	Flare Type LT	N/A	N/A	Flare Type RT	N/A
N/A	Flare Slope LT (%)	N/A	N/A	Flare Slope RT (%)	0.0
N/A	Flare Traversable LT?	N/A	N/A	Flare Traversable RT?	N/A
N/A	Landing Length (in)	0.0	N/A	DWS Provided?	N/A
N/A	Landing Width (in)	0.0	N/A	DWS Contrast?	N/A
N/A	Landing Slope (%)	0.0	N/A	DWS Length (in)	N/A
N/A	Landing X Slope (%)	0.0	N/A	DWS Full Width?	N/A
N/A	Landing Curb? (Y/N)	N/A	N/A	DWS Offset LT (in)	N/A
N/A	Shared Landing?	N/A	N/A	DWS Offset RT (in)	N/A
N/A	Gutter Ponding?	0.0	N/A	Gutter Slope (%)	N/A
N/A	Gutter Lip Ht (in)	0.0	N/A	Gutter X Slope (%)	N/A
N/A	Painted X Walk1?	No		Road Slope (%)	4.8
	X Walk 1 Direction	To E		Road X Slope (%)	3.0
	X Walk 1 Width (in)	N/A		Clear Space?	N/A

X Walk 1 Slope (%)	4.8	N/A	Clear Space to XWalk (in)	N/A
	X Walk 1 X Slope (%)	3.0	N/A	Storm Grate/Utility Hazard?	N/A
N/A	Ramp inside XWalk1?	N/A		Storm Grate/Utility Type	
N/A	Any Obstructions?	N/A			N/A
	Obstruction Type		Yes	Surface Condition? (G/P)	Good
			N/A	Curb Slope (%)	10.9

Remove & Replace Entire Ramp.
