Access Compliance Report

Public Rights-of-Way

(Curb Ramps)

Intersection ID: 14195		Main Street: CLEVELAND_AV		Cross Street: EAST_BV		Location: W											
ADA ID: EF07A8BA36DC		Ramp Type: Directional1		Initial Pass/Fail: Fail		Overall Compliance: No		Severity Score: 12.5									
Codes/Mitigation Info/Possible Solution				Field Measurements/Component Compliance													
<div>

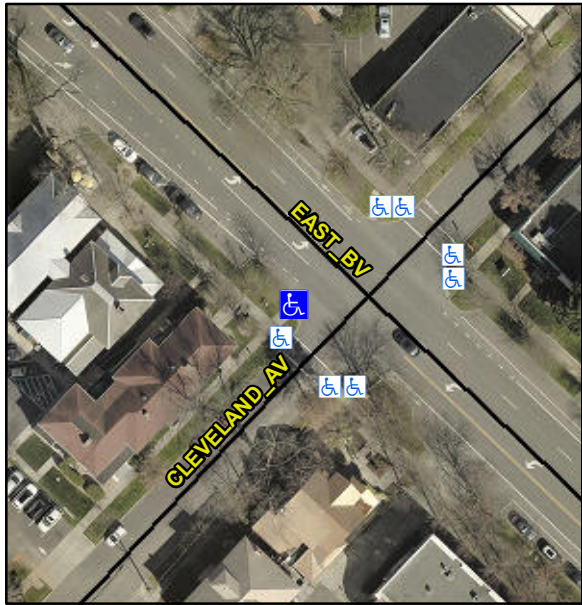
Yes		Ramp Slope (%)		6.6		N/A		Grade Break XSlope (%)		0.0			
				No		Ramp XSlope (%)		5.6									
				N/A		Flare Type LT		N/A		N/A		Flare Type RT		N/A			
				N/A		Flare Slope LT (%)		N/A		N/A		Flare Slope RT (%)		0.0			
				N/A		Flare Traversable LT?		N/A		N/A		Flare Traversable RT?		N/A			
				N/A		Landing Length (in)		0.0		N/A		DWS Provided?		N/A			
				N/A		Landing Width (in)		0.0		N/A		DWS Contrast?		N/A			
				N/A		Landing Slope (%)		0.0		N/A		DWS Length (in)		N/A			
				N/A		Landing X Slope (%)		0.0		N/A		DWS Full Width?		N/A			
				N/A		Landing Curb? (Y/N)		N/A		N/A		DWS Offset LT (in)		N/A			
				N/A		Shared Landing?		N/A		N/A		DWS Offset RT (in)		N/A			
				N/A		Gutter Ponding?		0.0		N/A		Gutter Slope (%)		N/A			
				N/A		Gutter Lip Ht (in)		0.0		N/A		Gutter X Slope (%)		N/A			
				N/A		Painted X Walk1?		No				Road Slope (%)		3.2			
						X Walk 1 Direction		To NE				Road X Slope (%)		0.7

</div> <div>Possible Solutions:</div> <div>Remove & Replace Entire Ramp.</div> <div>Surveyor Notes:</div> <div>N/A</div> <div>PROW/ADA:</div> <div>R304.5.3</div> <div>Street 1 Name</div> <div>EAST BV</div> <div>Stop Condition-Street 1</div> <div>None</div> <div>Street 2 Name</div> <div>N/A</div> <div>Stop Condition-Street 2</div> <div>N/A</div> <div>Total Cost:</div> <div>\$</div> <div>1600.00</div>				Compliance		Description		Data		Compliance		Description		Data			
				N/A		Ramp Length (in)		73.5		N/A		Grade Break?		N/A			
				Yes		Ramp Width (in)		72.0		N/A		Grade Break Slope (%)		0.0
