# Access Compliance Report

## Public Rights-of-Way

### (Curb Ramps)

| Intersection ID: 42359 | Main Street: HERON_GLEN_DR | Cross Street: WRENS_NEST_LN | Location: | N |

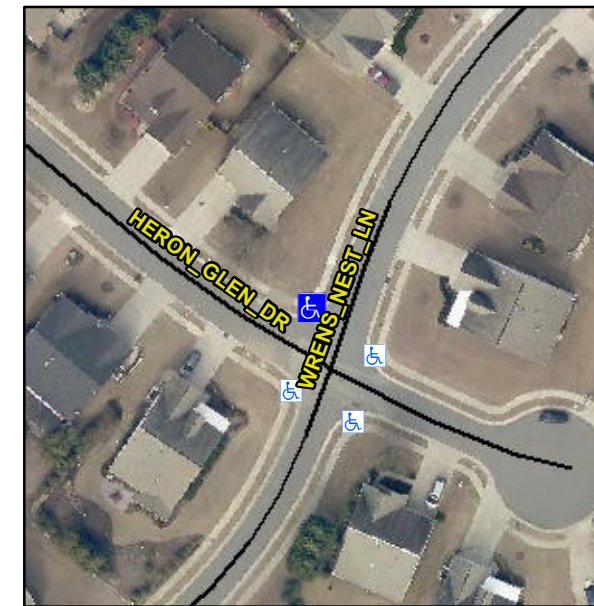
| ADA ID: EF0A875FA61D | Ramp Type: PerpDiag | Initial Pass/Fail: Pass | Overall Compliance: No | Severity Score: 10 |

| Compliance | Description | Data | Compliance | Description | Data |
|---|---|---|---|---|---|
| Yes | Landing Length (in) | 48.0 | No | DWS Provided? | No |
| No | Landing Slope (%) | 5.4 | N/A | DWS Length (in) | N/A |

**Remove & Replace Curb Ramp With Two New Directional Ramps or Equivalent.**

**R304.2.2-Perp, R304.3.2-Para, R305**

Total Cost: \$ 3200.00
