Access Compliance Report

Public Rights-of-Way

(Curb Ramps)

Intersection ID: 10036258	Main Street: ROMANY_RD	Cross Street: N/A	Location: SW
ADA ID: EF1C449B368B	Ramp Type: PerpDiag	Initial Pass/Fail: Fail	Overall Compliance: No
		Severity Score: 35

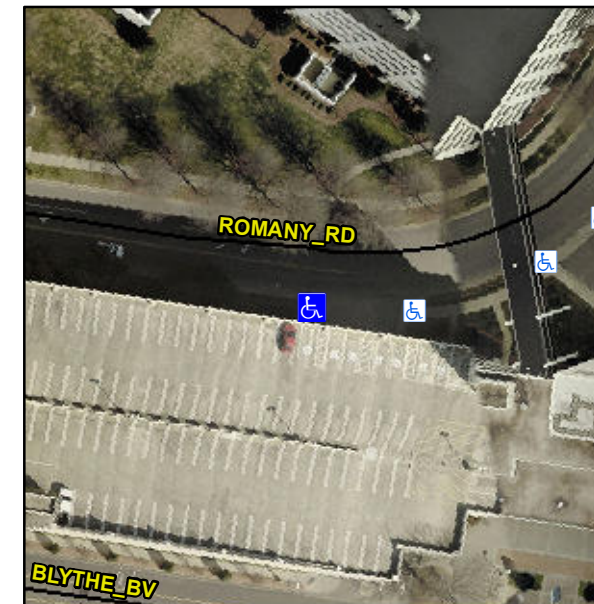
Compliance	Description	Data	Compliance	Description	Data
N/A	Ramp Length (in)	44.0	No	Ramp Slope (%)	16.2
No	Ramp Width (in)	37.0	No	Ramp XSlope (%)	2.9
N/A	Flare Type LT	N/A	N/A	Flare Type RT	N/A
N/A	Flare Slope LT (%)	N/A	N/A	Flare Slope RT (%)	N/A
N/A	Flare Traversable LT?	N/A	N/A	Flare Traversable RT?	N/A
N/A	Landing Length (in)	N/A	N/A	DWS Provided?	N/A
N/A	Landing Width (in)	N/A	N/A	DWS Contrast?	N/A
N/A	Landing Slope (%)	N/A	N/A	DWS Length (in)	N/A
N/A	Landing X Slope (%)	N/A	N/A	DWS Full Width?	N/A
N/A	Landing Curb? (Y/N)	N/A	N/A	DWS Offset (in)	N/A
N/A	Shared Landing?	N/A			
N/A	Gutter Ponding?	N/A	N/A	Gutter Slope (%)	N/A
N/A	Gutter Lip Ht (in)	N/A	N/A	Gutter X Slope (%)	N/A
N/A	Painted X Walk1?	No	N/A	Painted X Walk2?	No
	X Walk 1 Direction	To NE		X Walk 2 Direction	To NW
N/A	X Walk 1 Width (in)	N/A	N/A	X Walk 2 Width (in)	N/A
	X Walk 1 Slope (%)	0.4		X Walk 2 Slope (%)	0.9
	X Walk 1 X Slope (%)	3.3		X Walk 2 X Slope (%)	2.0

N/A	Ramp inside XWalk1?	N/A	N/A	Ramp inside XWalk2?	N/A
	Road Slope (%)	1.2	N/A	Clear Space?	N/A
	Road X Slope (%)	3.1	N/A	Clear Space to XWalk (in)	N/A
N/A	Any Obstructions?	N/A	N/A	Storm Grate/Utility Hazard?	N/A
	Obstruction Type			Storm Grate/Utility Type	
		N/A			N/A
			Yes	Surface Condition? (G/P)	Good

Remove & Replace Curb Ramp With Two New Directional Ramps or Equivalent.

R304.5.1, R304.2.2, R304.5.3
